Board Report

SUBJECT: OFFICE OF THE INSPECTOR GENERAL REPORT ON REVIEW OF METRO SAFETY CULTURE AND RAIL OPERATIONAL SAFETY

Attachment A - Report on Review of Metro Safety Culture and Signal Violations

LA Metro Safety Culture and Rail Operational Safety Review

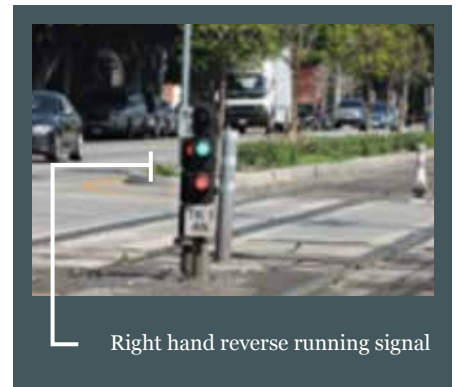
Although Metro has adopted a standard to install wayside signals on the left side of the track, many signal locations include right hand signals. This could lead to confusion on the part of train operators, especially at locations where normal and reverse running signals are installed side by side. Metro’s representatives indicated that the main reason for this deviation is to separate interlocking signals from traffic signals. However, it should be noted that reverse running signals are facing opposite to train traffic, and should not be visible to automobile drivers.

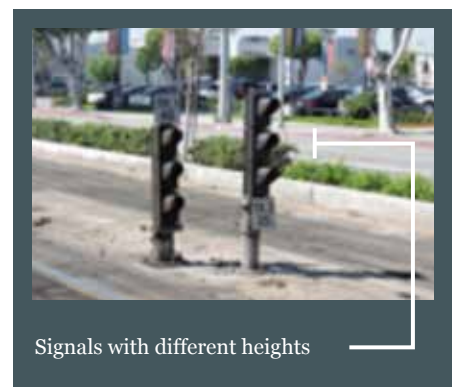
There is a lack of standards regarding the placement of wayside signals versus the Rail Operator’s direct line of sight. Signal height, for example, varies from location to location and in some cases a signal is raised in an attempt to differentiate it from an adjacent signal. This condition was also observed by the APTA Peer Panel.

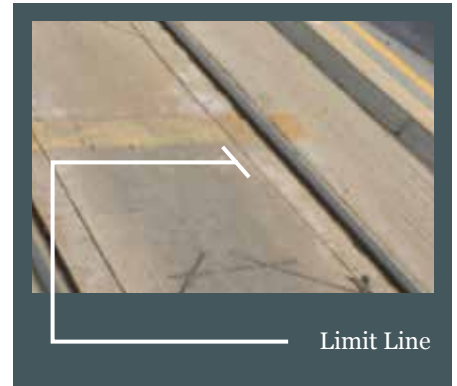
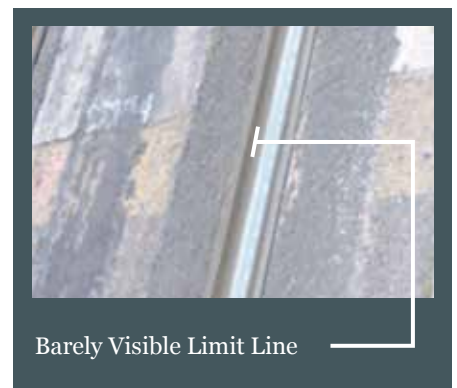
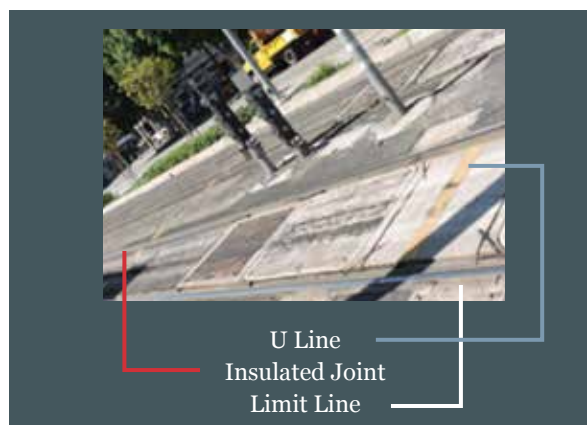
Further, at certain locations on the Expo Line, two yellow lines were observed in the vicinity of a signal location: the “Limit Line”, and a second line passed the signal at an insulated joint location (IJ Line).

A review of the Operating Rules and Procedures reveal that a “Limit Line” is not defined. However, a “Fouling Point Marker” is described. It is not clear if the “IJ Line” observed at certain locations is actually a “Fouling Point Marker”.

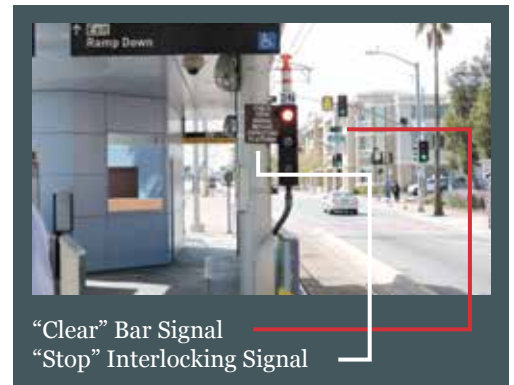
1. The interlocking signal displays a “stop” indication, while the semaphore bar signal displays a “proceed” indication, and
2. The interlocking signal displays a “proceed” indication, while the semaphore bar signal displays a “stop” indication.

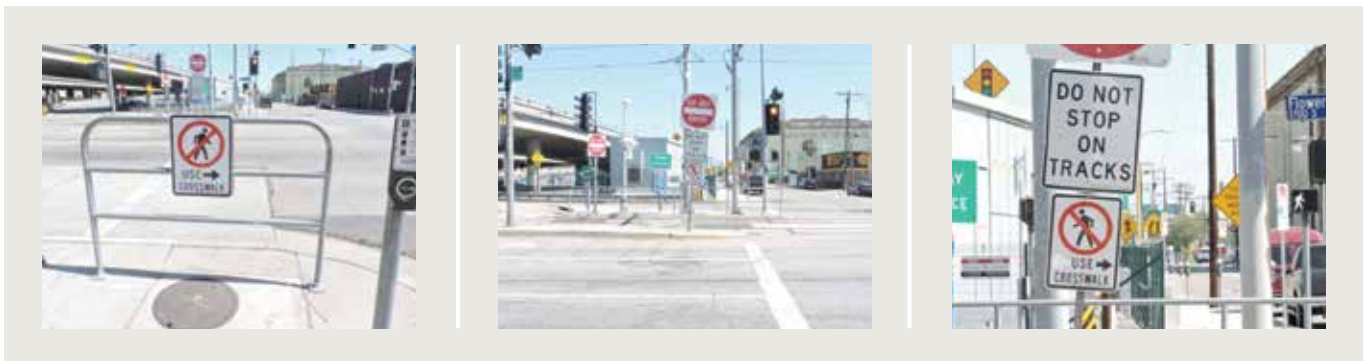
Signage

There are a number of pedestrian and vehicle signs that are missing at this intersection. They include:

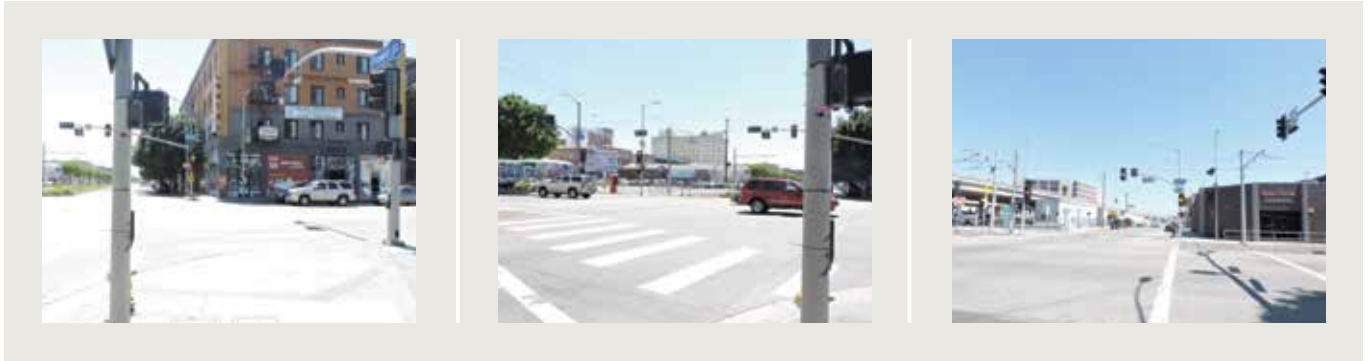
The street markings for pedestrians and vehicles at this intersection provide basic guidance for pedestrians, and are in fair condition.

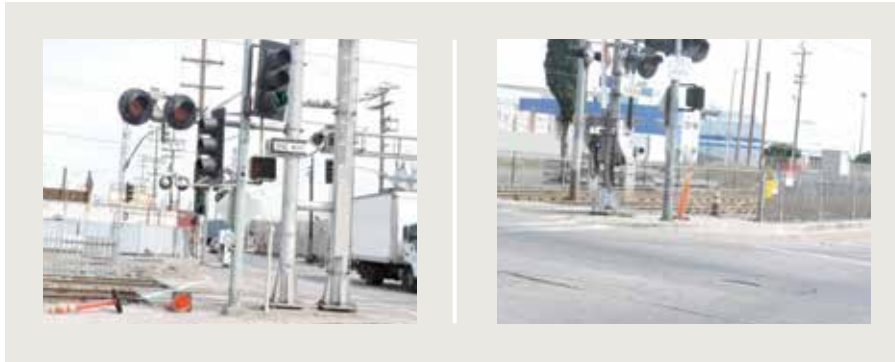
During our site visit at this location, we observed that the temporary identifier used to identify priority signal locations is placed on the right of way in an attempt to create a pedestrian barrier. It is not a good practice to use this temporary identifier in a different application that is not associated with a priority signal location. Such practice dilutes the safety intent of this temporary identifier.

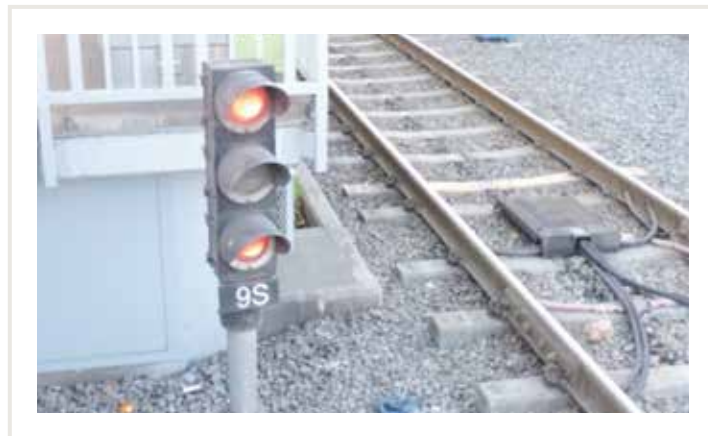
- Signal 9S is installed at the entrance to the station. Its function is to control the movement of a train into the station. It normally displays a FG/R (Flashing Green over Red) if there is no train at the platform. If a train is berthed at the platform, signal 9S displays R/R (Rule 3082). Also, this signal is located at the boundary between street running and ATP (cab-signaling) territory. There is a sharp curve in the approach to the signal, which results in a short sighting distance for the signal. Further, there is no enforcement at this signal, and safety of operation depends entirely on compliance with operating rules and procedures.

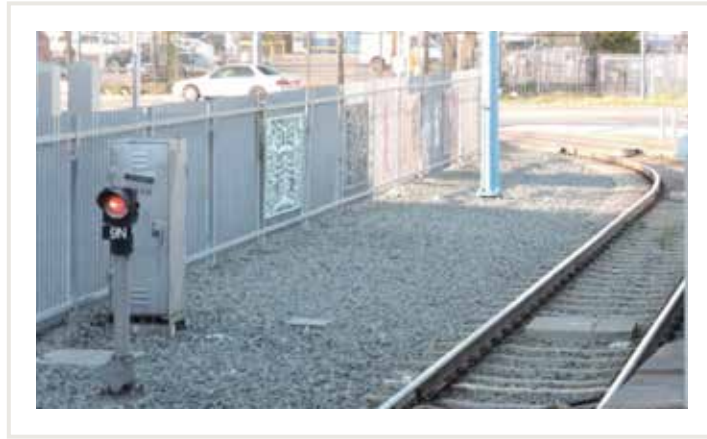
- Signal 9N is a reverse running signal located at the entrance to street running territory. It normally displays a “Red” aspect, and requires authorization from the ROC to proceed (Rule 3082). This signal is at the approach to a sharp curve.
