Board Report

**SUBJECT: OFFICE OF THE INSPECTOR GENERAL REPORT
ON REVIEW OF METRO RAIL SERVICE DISRUPTIONS**

Review of Metro Rail Service Disruptions

Briefing on the Metro Rail Service Disruption Review

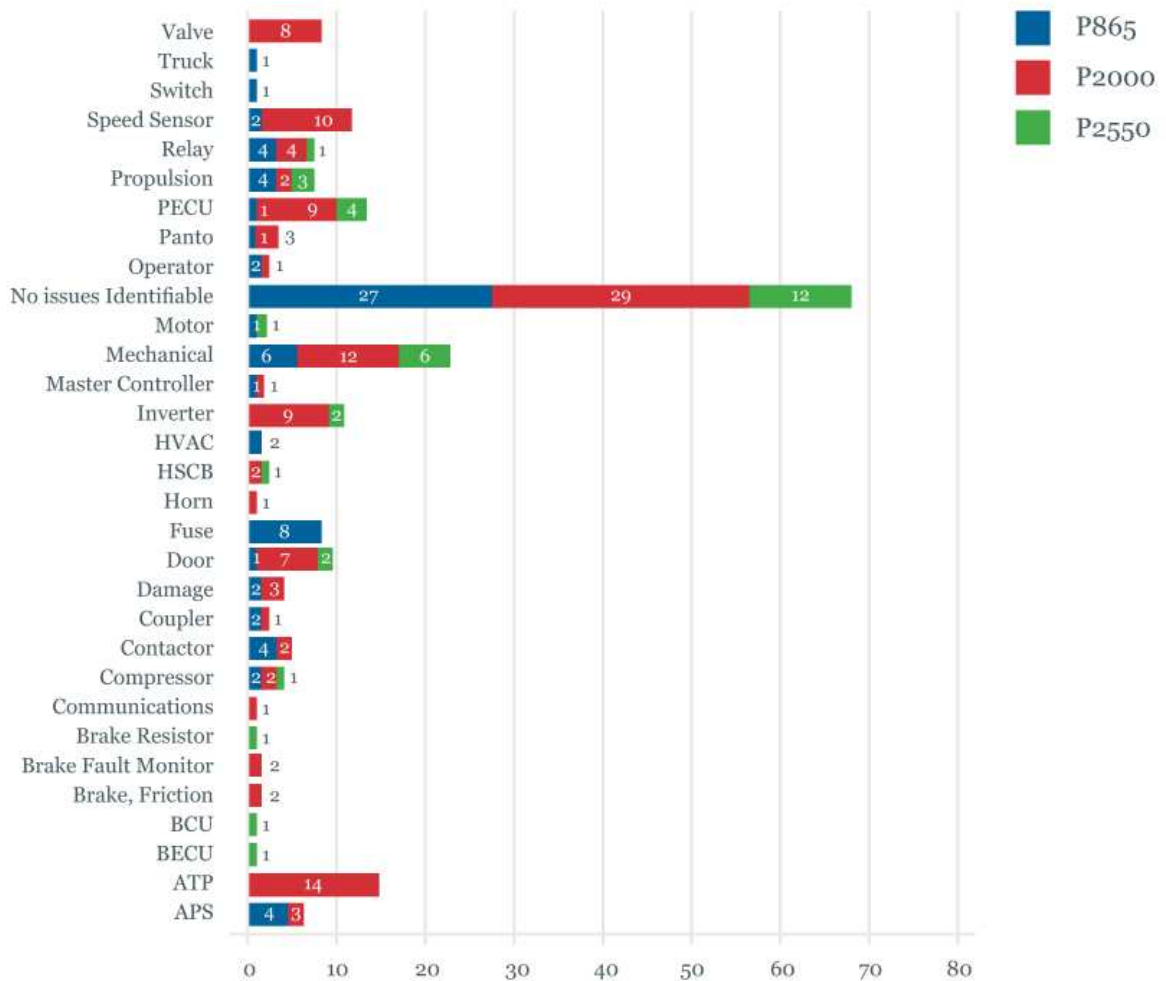
Figure 7: Causes of Rail Vehicle Incidents - Light Rail

- P2550 0.84
- P865/2020 1.08
- P2000 2.48

10. Given the large number of incidents where no root cause was identifiable, establish a procedure to instruct vehicle maintenance personnel on providing consistent and complete detailed information related to vehicle failures in the WO reports. While awaiting a new log-in system with a consistent and nested drop down of primary causes of vehicle failure on incident reports, redesign work order forms along these lines, with a consistent section and checklist for identifying root cause.

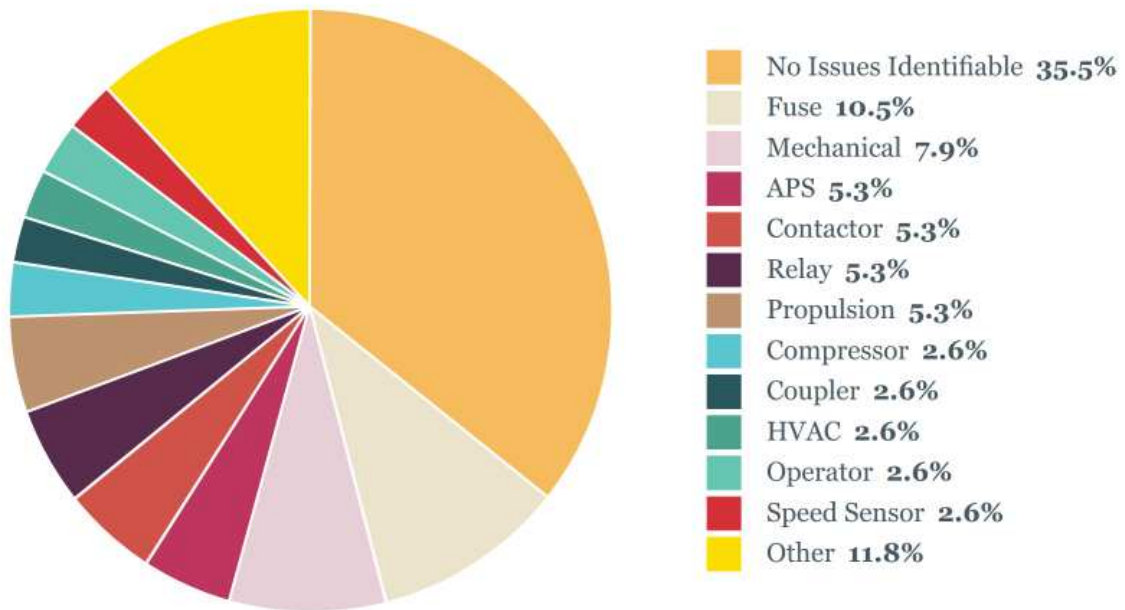
Figure 8: Causes of Rail Vehicle Incidents - Light Rail (P865 & P2020)

C7. 11.8% of the incidents categorized as “Other” were single incidents caused by the following subsystems:

- Automatic Train Protection (ATP)
- Brake Electric Control Unit (BECU)
- Friction brakes
- Propulsion Electric Control Unit (PECU)
- Doors
- Master controller
- Pantograph (Panto)
- Control switch
- Truck

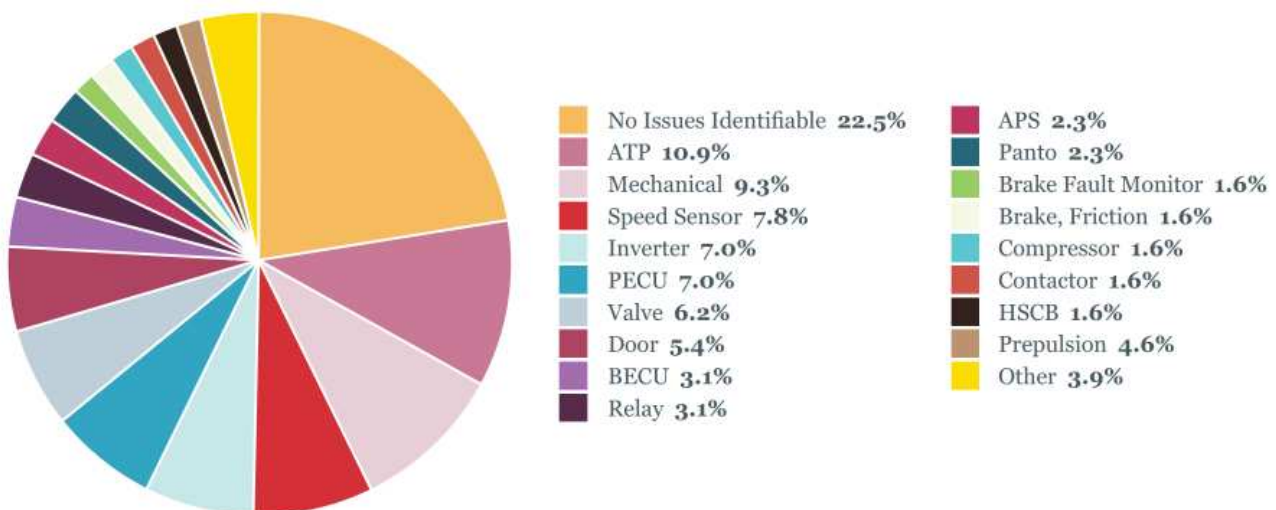
Figure 10: Causes of Rail Vehicle Incidents - Light Rail (P2000)

C18. 14% of the incidents were propulsion related (Inverter 7% and PECU 7%) and resulted in an average maximum delay of 10.1 minutes per car.

C19. 10.9% of the incidents were ATP/ATO related issues and generated an average maximum delay was 10.2 minutes per car.

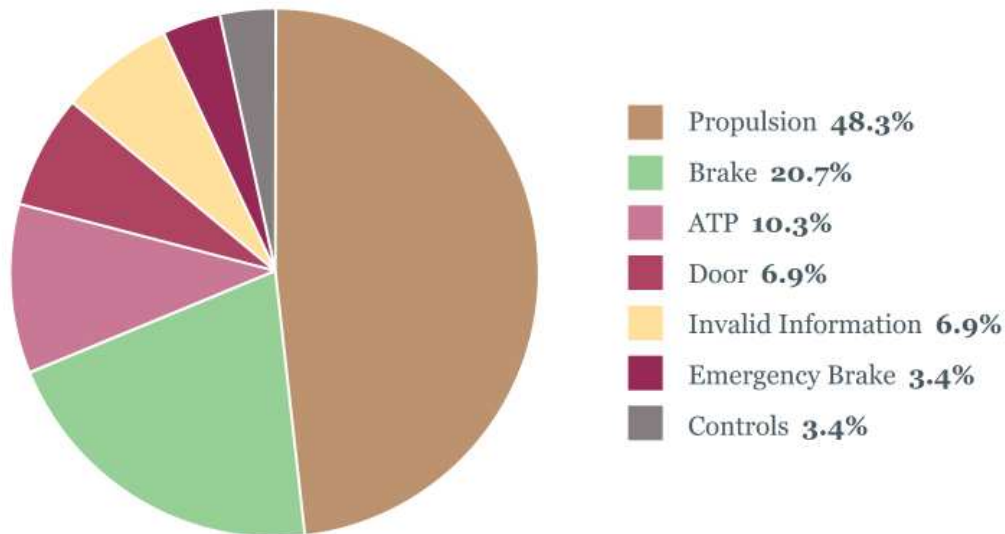
Figure 11: No Issues Identifiable (P2000)

- The chart above shows that 48.3% of no issue identifiable incidents were reported as propulsion issues. This indicates that the propulsion system diagnostics are more complicated than on the P865 and P2550 cars.
- The average maximum delay of these incidents was: 9.6 minutes per car.

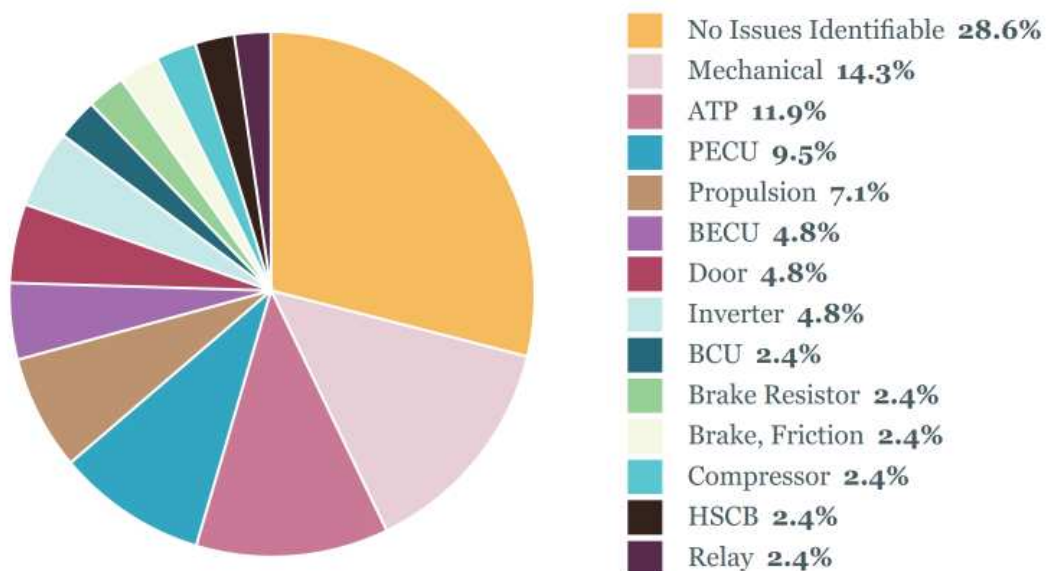
Figure 12: Causes of Rail Vehicle Incidents - Light Rail (P2550)

C28. 16.6% of the incidents were propulsion related (categorized as 7.1% propulsion and 9.5% PECU), caused by either inverter, sensors or electronic (PECU) failures. The average maximum delay for propulsion related incidents was 8 minutes.

C29. 14.3% of the incidents were mechanical in nature, such as misaligned speed sensors, clogged air ducts, misaligned doors, and misaligned hinges. The average maximum delay of these incidents was 9.3 minutes per incident.

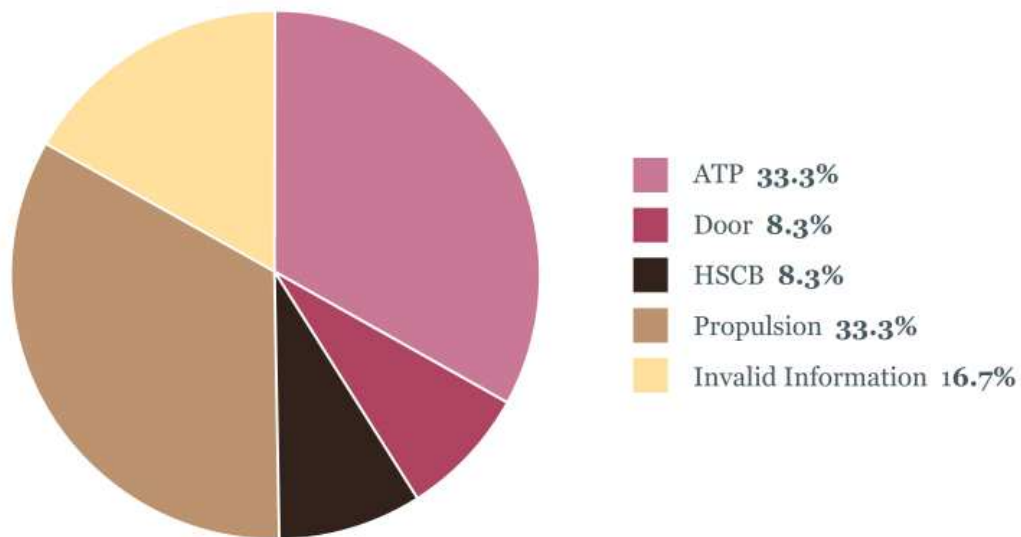
Figure 13: No Issues Identifiable (P2550)

- The average maximum delay of these “unidentifiable” incidents was 11.4 minutes.

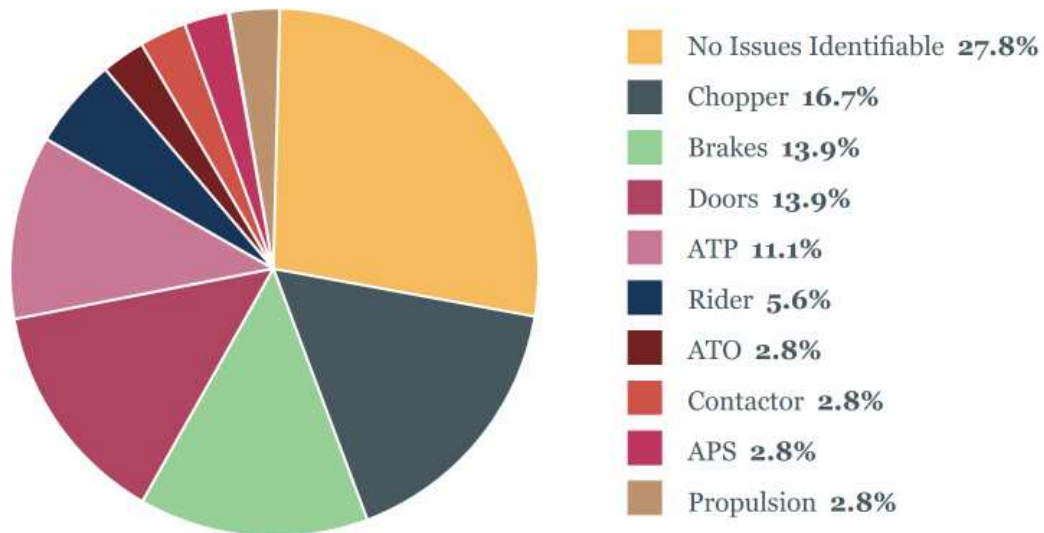
Figure 15: Causes of Rail Vehicle Incidents - Subway (Base Buy)

C37. 19.5% of the incidents were caused by the Chopper and other propulsion related issues. The average maximum delay was 19.4 minutes per incident.

C38. 13.9% of the incidents were caused by the brake system. The average maximum delay was 8.4 minutes per incident. The much lower percentage of brake incidents on the GE vehicle suggests that the issues might be an interface issue with propulsion/vehicle controls since the GE vehicles use the same brake components.

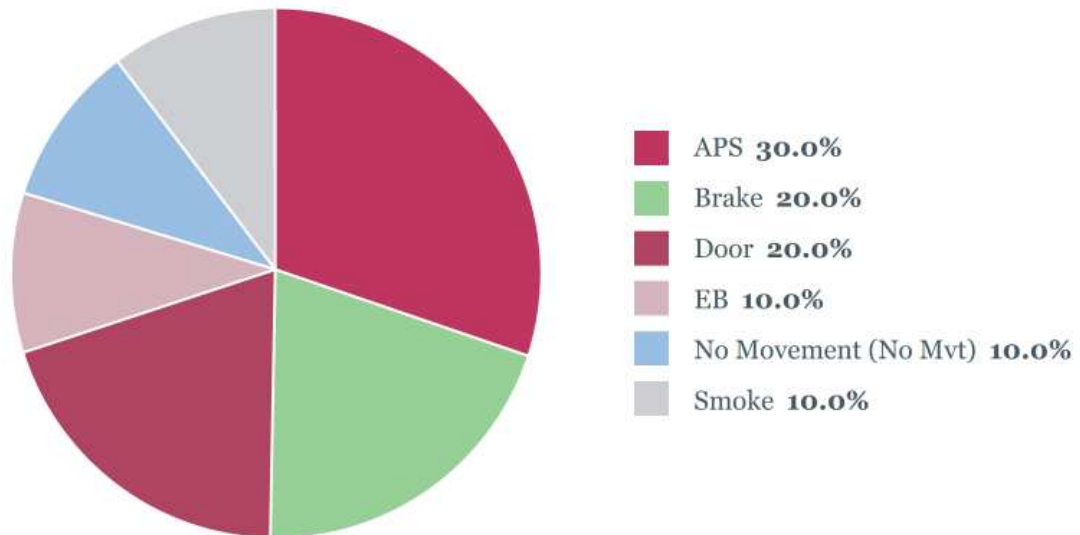
Figure 16: No Issues Identifiable (Base Buy)

- The average maximum delay of these incidents was 10.8 minutes. APS, brakes, and doors caused 70% of the incidents where no issues were identifiable as shown in the above chart.

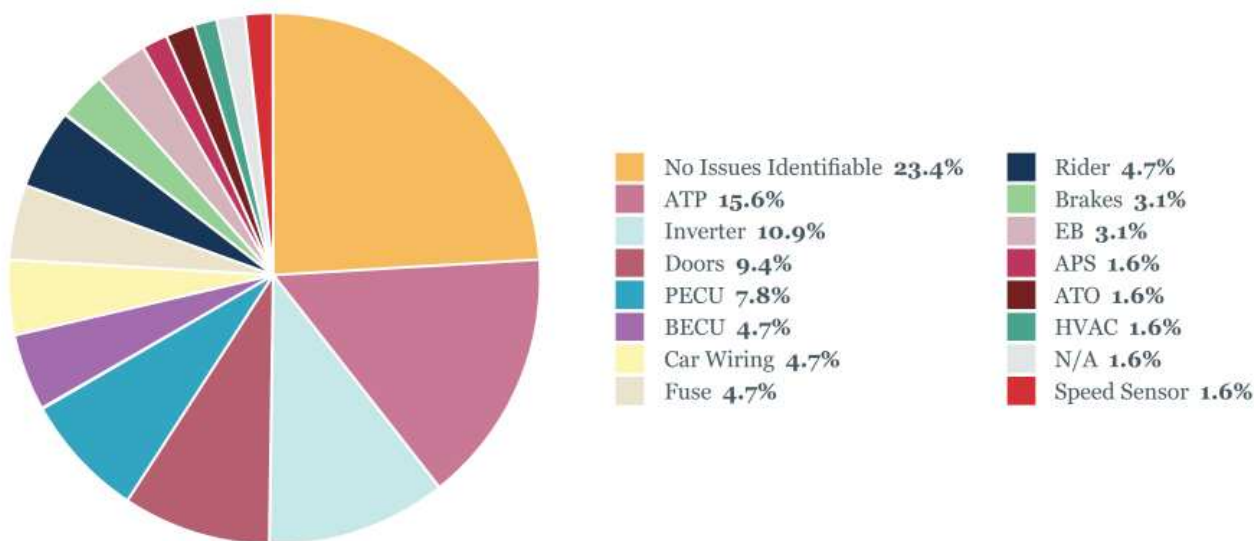
Figure 17: Causes of Rail Vehicle Incidents - Subway (GE)

C47. 18.7% of the incidents were caused by the propulsion system, mainly the inverter modules and the controls PECU. The average maximum delay was 9.25 minutes per incident.

C48. 15.6% of incidents were due to equipment failures of the ATO/ATP system. The average maximum delay was 9.6 minutes per incident.

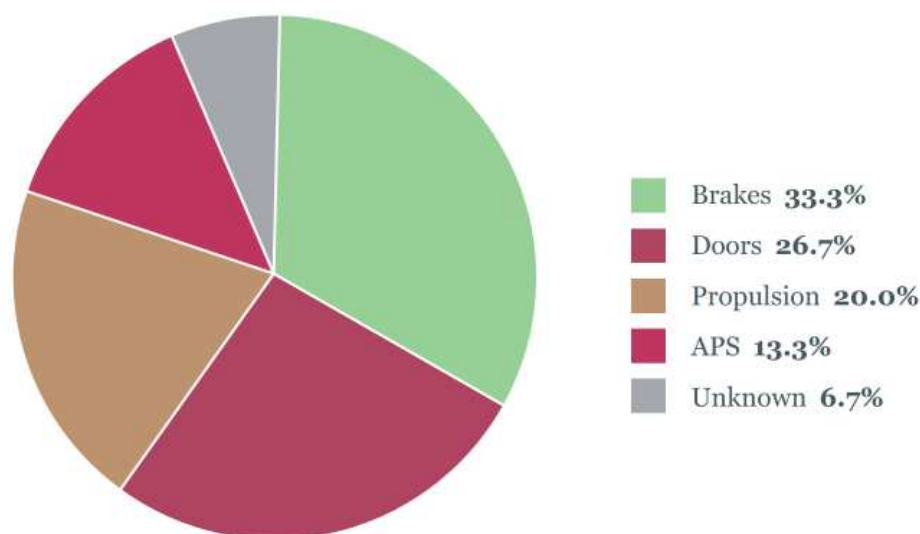
Figure 18: No Issues Identifiable - Subway (GE)

- The average maximum delay for incidents with no issue identifiable was 12.5 minutes per incident. Brakes, doors, and propulsion were reported in 80% of the incidents as the “cause” where no issues were identifiable.

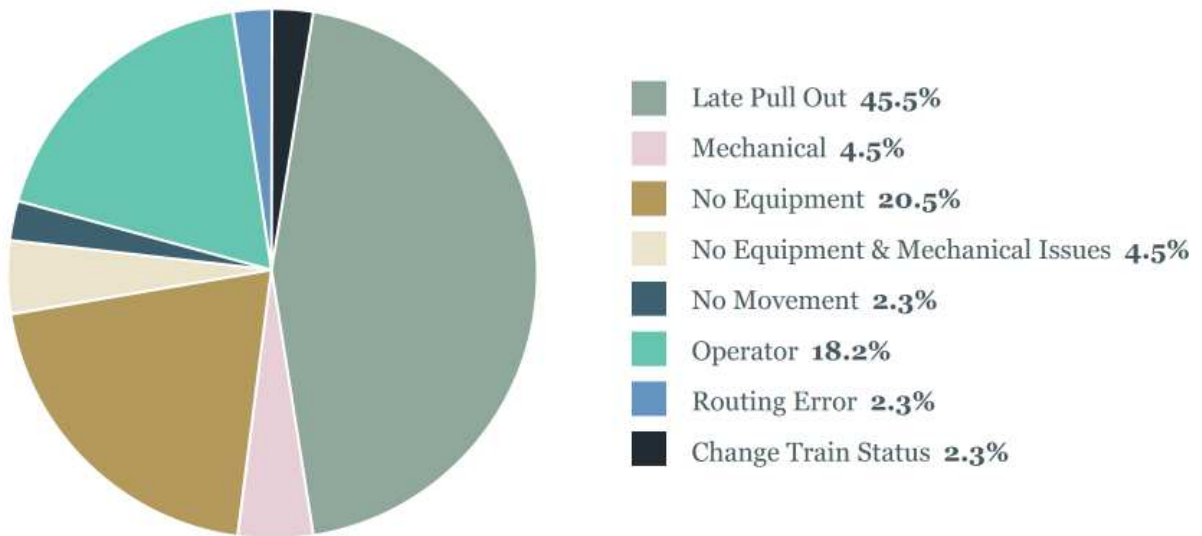
Figure 21: Causes of Yard Control Incidents (Light Rail)

E1. As shown in the above chart, the top three incidents due to Yard Control were late pull out (45.5%), no equipment (20.5%), and operator (18.2%) (mostly operator not available).

45. Limit the designation of Yard Control incidents to those actually attributed to yard issues.

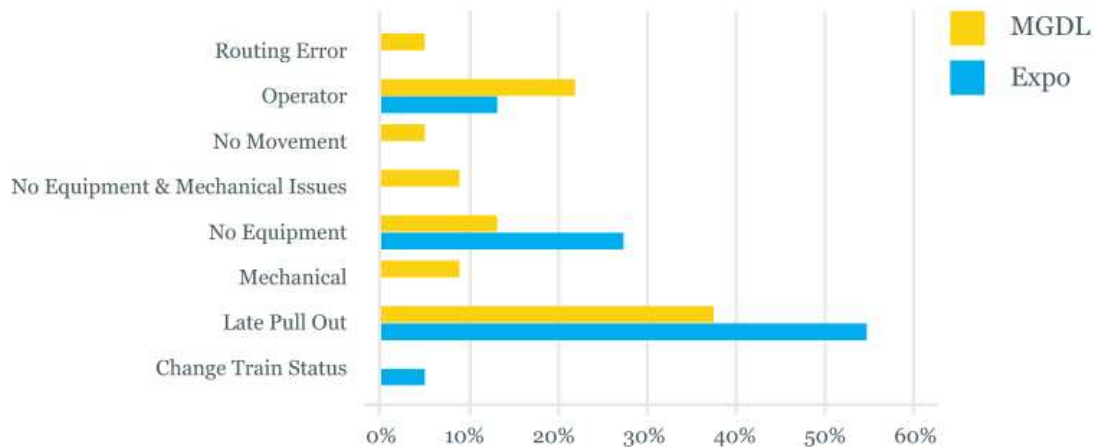
Figure 22: Causes of Yard Control Incidents by Line

E2. The analysis in Figure 22 shows that Yard Control related service delays were largely not specific to the yards.

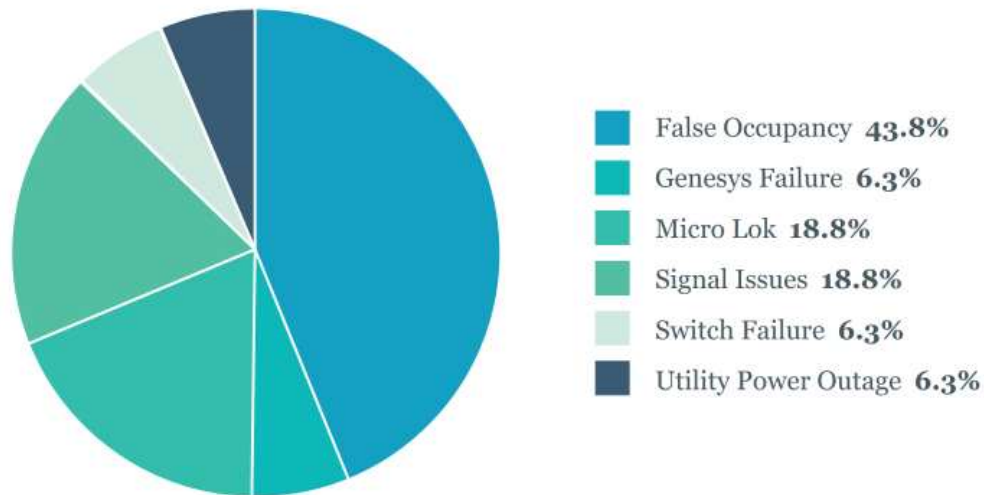
Figure 23: Causes of Signal Incidents - Light Rail (MGL)

Six causal categories were identified for Signal delays on MGL. As shown in the chart below, false occupancy, Micro Lok (an interlocking control system, manufactured by Ansaldo), and Signal issues accounted for 81.4% of all signal incidents on the MGL, although many of these did not identify root cause.

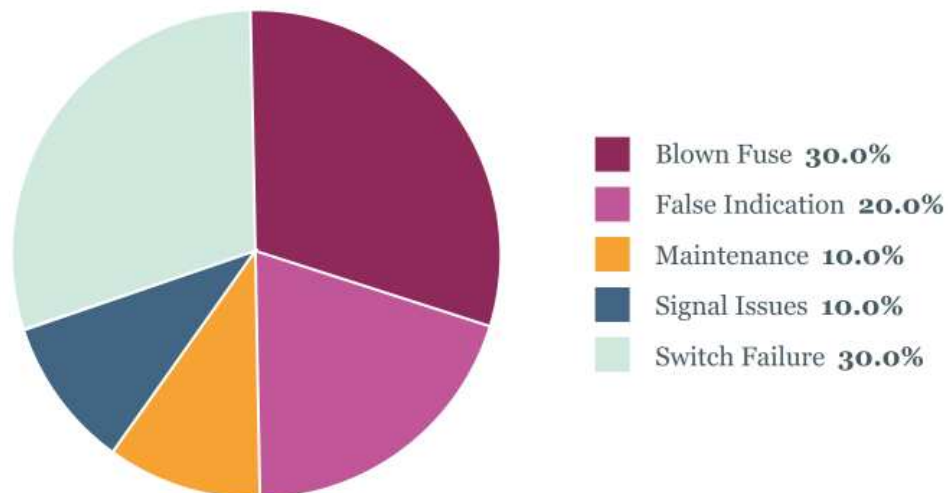
Figure 24: Causes of Signal Incidents - Subway Line (MRL)

Five causal categories were identified for signal delays on MRL. As shown on the chart below, blown fuse, switch failure and false occupancy accounted for 80% of these MRL signal delay incidents, although no systemic failure could be identified based on the low incidence of these delays and the information provided on the work orders.

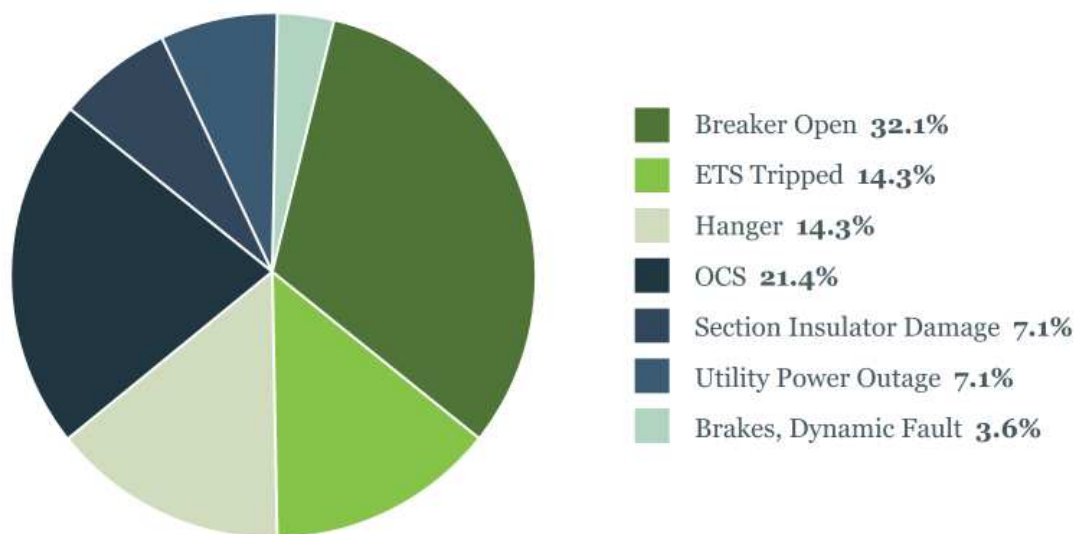
Figure 25: Causes of Traction Power Incidents - Light Rail (MBL)

- G1.** Traction power failures on the MBL resulted in 358 cancelled trips and 113 late trips in 2016.
- G2.** 12 out of 28 (43%) incidents were related to failures or interference with the catenary infrastructure (21.4% Overhead Contact System (OCS) failure, 7.1% section insulator damage, and 14.3% hanger interference and broken wires). The catenary failures resulted in 191 cancelled trips and 48 late trips.
- G3.** 9 out of 28 (32.1%) incidents were related to open breakers due to hardware failures or undetermined causes. The breaker failures resulted in 115 cancelled trips and 24 late trips.
