Board Report

SUBJECT: NEW BLUE/ EXPO SERVICE AND PROJECT MANAGEMENT

Metro Gold Line Overhead Catenary System

Gold Line Incident 1 – Monday, September 9, 2019

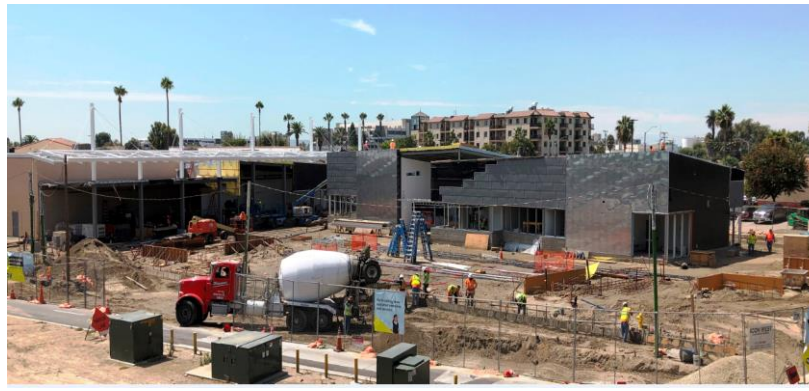
Expo Junction Trackwork

- Status: Completed (Saturday, June 22, 2019 – Friday, August 23, 2019)
- **Project Highlights:**
- New overhead contact rail (OCR) system (first ever at Metro)
- New #10 interlocking and track fasteners in Flower tunnel
- Rebuilt a portion of the Washington Junction and special trackwork
- Pico Station painting, tile renewal, digital map cases, and new signage
- All work completed around the clock within 60 day allocated closure window.

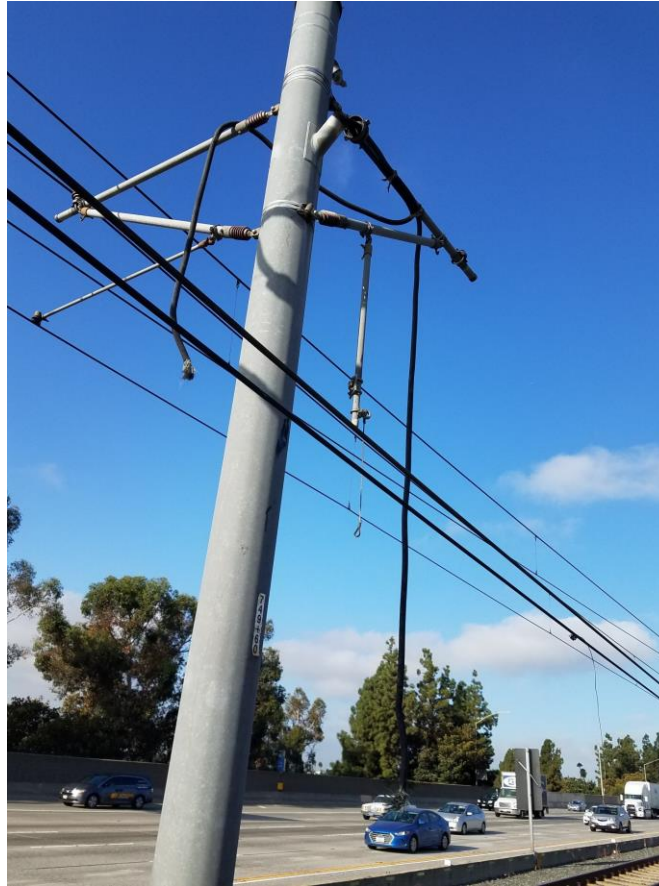
Gold Line Incident 1 – OCS Damage

- A dog bone insulator broke at a balance weight assembly, causing the OCS wire to sag far below normal operating height
- As a vehicle traveled on track 2, it collided with the OCS wire, damaging OCS assemblies and 1500 feet of messenger/contact wire

Safety tether installation

- ✓ Two crews with 10 Inspectors and a Supervisor worked to repair damage
- ✓ OCS cantilever arms were reconnected to OCS poles
- ✓ Replacement of the dog bone fiberglass insulator rod
- ✓ Raising of the messenger and contact wire
- ✓ Reconnection of the wire assembly to the weight stack (safety tether)

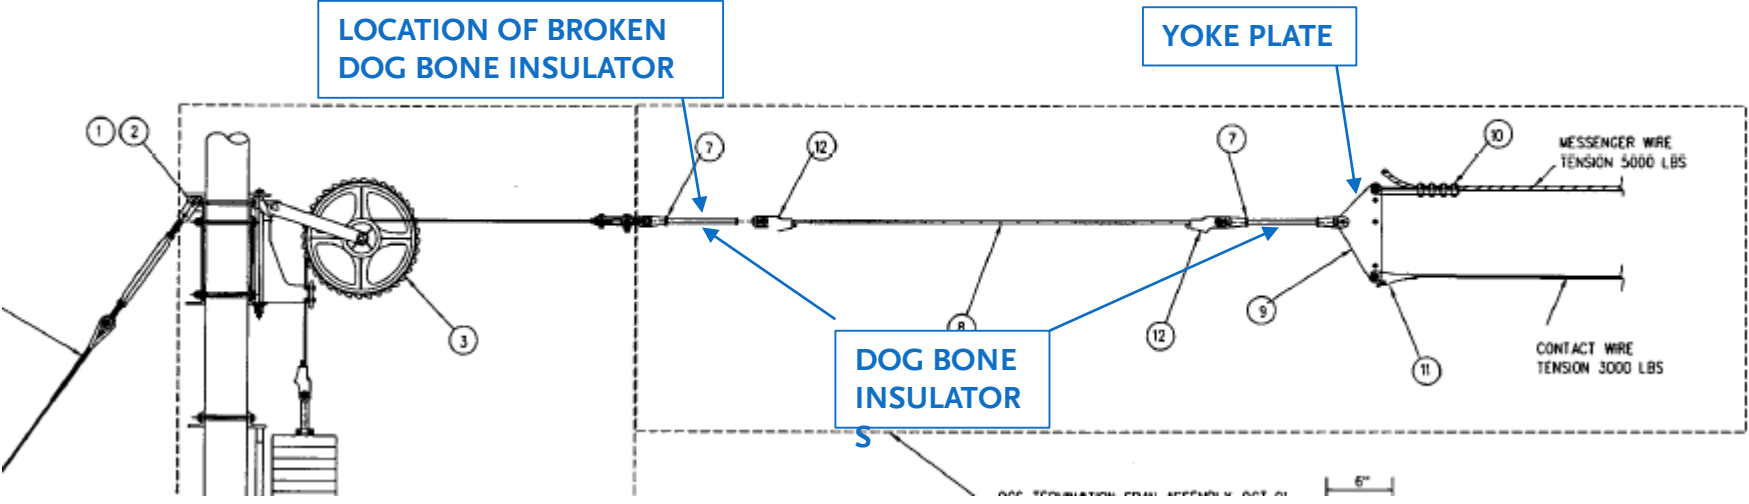
DETAIL DRAWING OF ASSEMBLY

Incident Assembly Configuration – Gold Line Pasadena Section

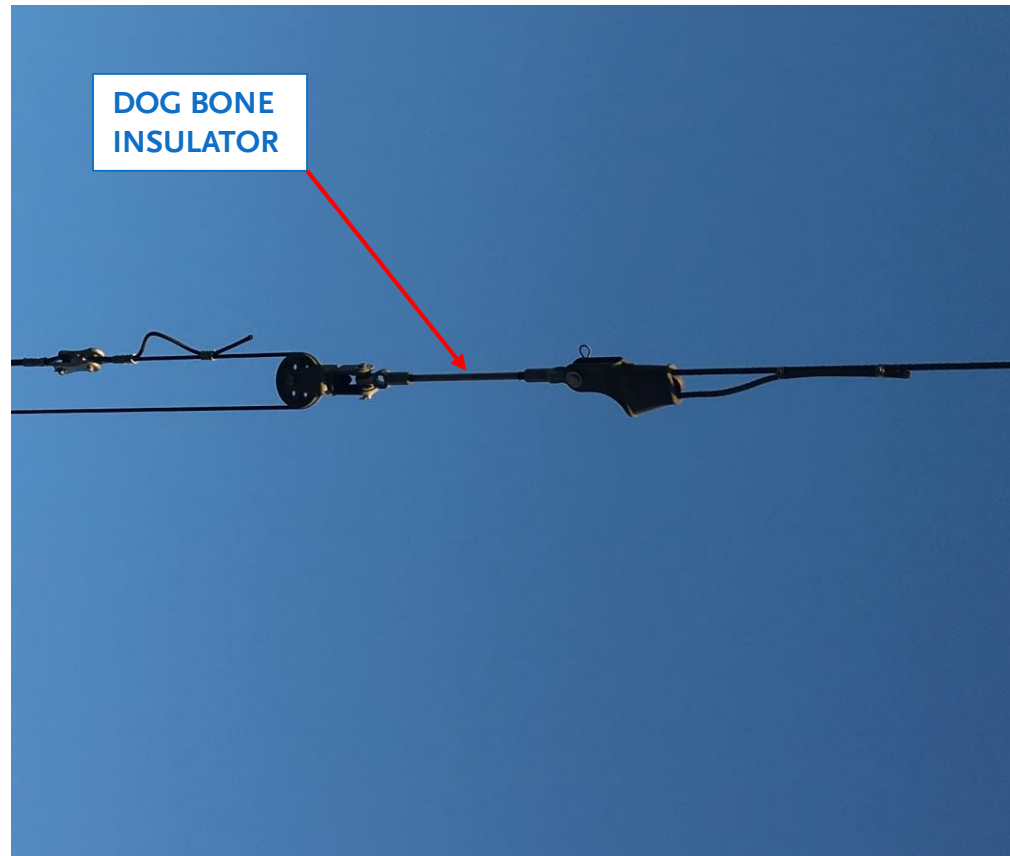
**FIELD PHOTO OF BALANCE WEIGHT ASSEMBLY
(NEAR BALANCE WEIGHTS)**

A dog bone insulator broke at a balance weight assembly, causing the OCS wire to sag below normal heights. As a vehicle traveled on track 1, it's pantograph snagged on the wire, damaging the OCS supports and assemblies.

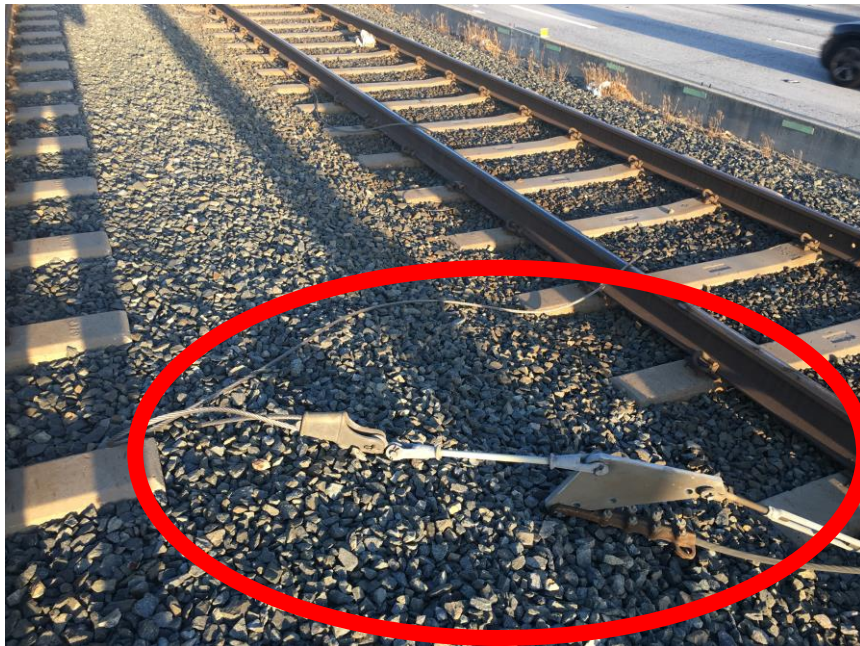
Service Restoration Efforts & Safety Tether Information

Locations with Existing Safety Tethers: Blue Line, Green Line, Gold Line Eastside & Foothill Extensions, Expo Line, and Crenshaw Line
