*Los Angeles County Metropolitan Transportation Authority
One Gateway Plaza
3rd Floor Board Room*

Agenda - Final

Thursday, January 19, 2017

LA Metro Safety Culture and Rail Operational Safety Review

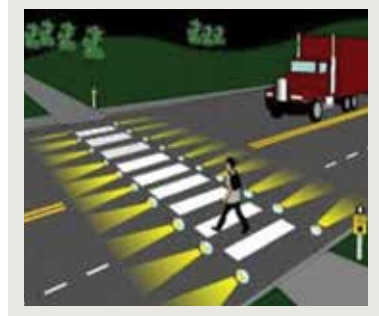
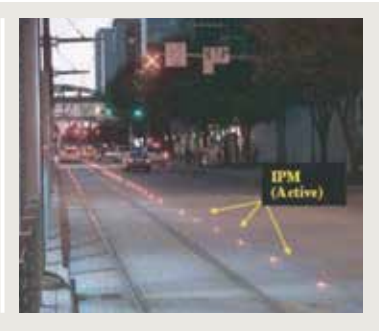
Lighted pedestrian crosswalks provide an effective guide as to where pedestrians should cross at an intersection.

Illuminated active in-pavement marking (IPM) systems, when installed parallel to the light rail transport (LRT) alignment, are effective in alerting vehicle drivers that a train is approaching the intersection. IPM systems discourage vehicle drivers from violating turn signals at intersections. TWG is advised that Metro has installed similar systems at pilot locations.

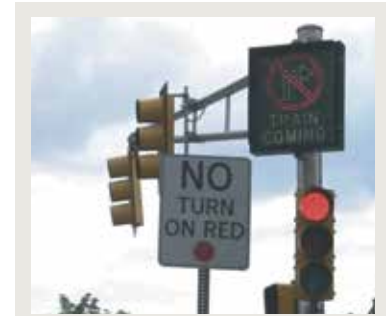
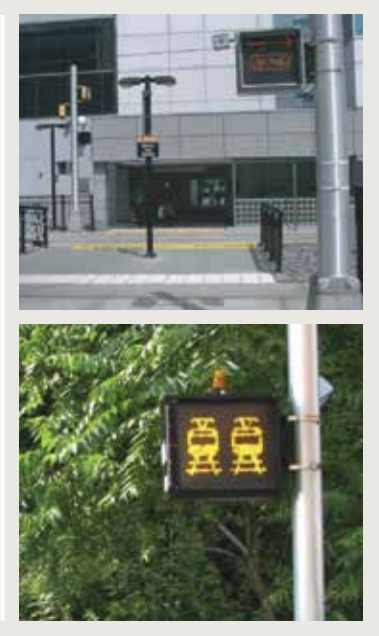
The use of “Blank Out” signs (example an illuminated no turn on red) is effective in advising motorists and pedestrians of increased risk due to the presence of a light rail vehicle (LRV) at a crossing location. TWG is advised that Metro has installed these signs at a number of locations.

The use of “Second Train Signals” is effective in advising motorists and pedestrians that two trains are approaching an intersection. This is an active sign that illuminates when one or two trains are approaching. The sign may be a blank-out LED sign or it may use flashing lights or another type of indication (such as backlit illumination) to an otherwise static sign. TWG is advised that Metro has installed these signs at a number of locations.

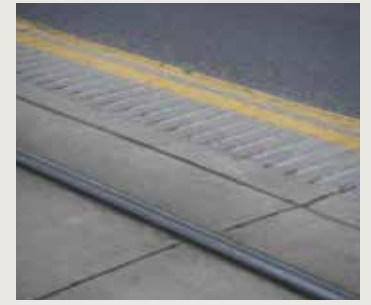
Rumble strips are effective in alerting drivers when they leave their lane, infringing on the LRT right-of-way. TWG is advised that Metro has installed curb which they consider better than rumble strips.

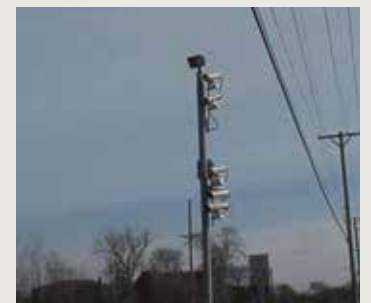
Automatic photo enforcement system is effective in deterring motorists from deliberately violating traffic laws at intersections. TWG observed that Metro installed photo enforcement at a number of LRT crossings.

- 64.** Metro should review each of the above listed best practices against what it has already implemented to identify any remaining locations to improve operational safety at intersections, and encourage safe public behavior.

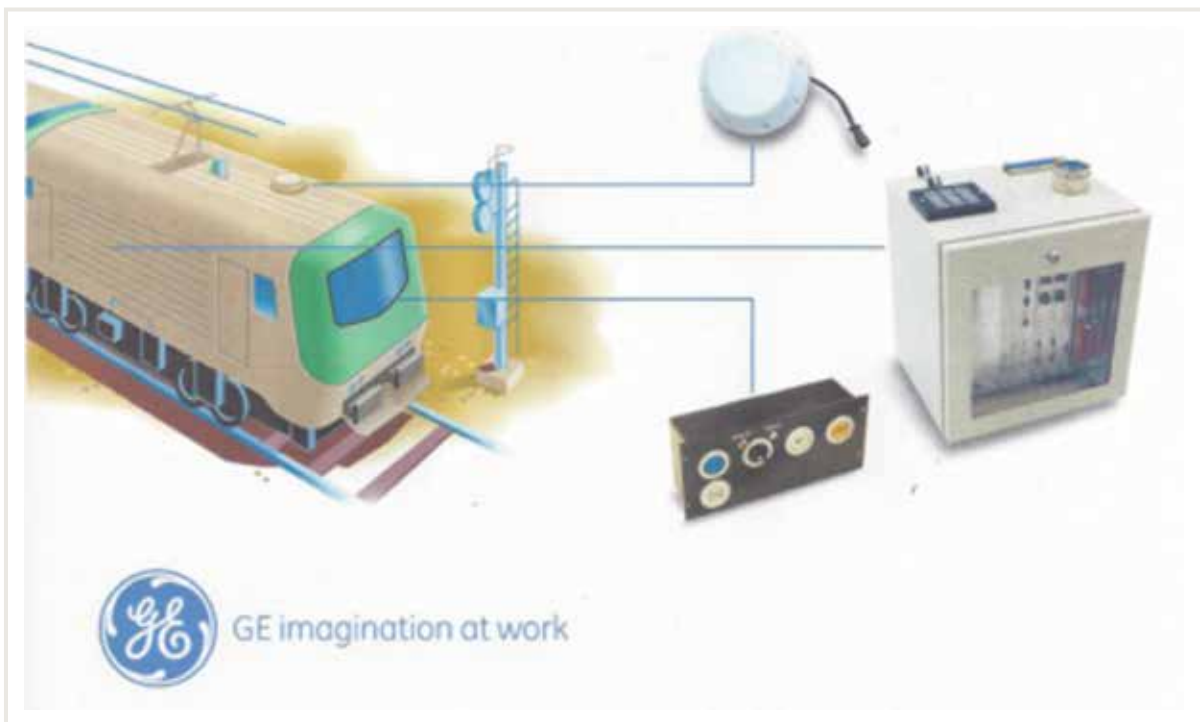
A second technological approach that is also challenging to implement is to employ microwave to transmit the status of an interlocking signal to an approaching train. This SSC-ATP system from General Electric does not require devices or cables mounted in the track area. Its wayside components are mounted on the track, deriving their power from the existing signals, eliminating the need for new power cables. The system uses microwave technology to transmit signal and track information to the train. Onboard equipment is used to provide a wide range of applications from simple warning devices that the interlocking signal ahead is displaying a “stop” aspect, to an enforcement of the signal aspect.

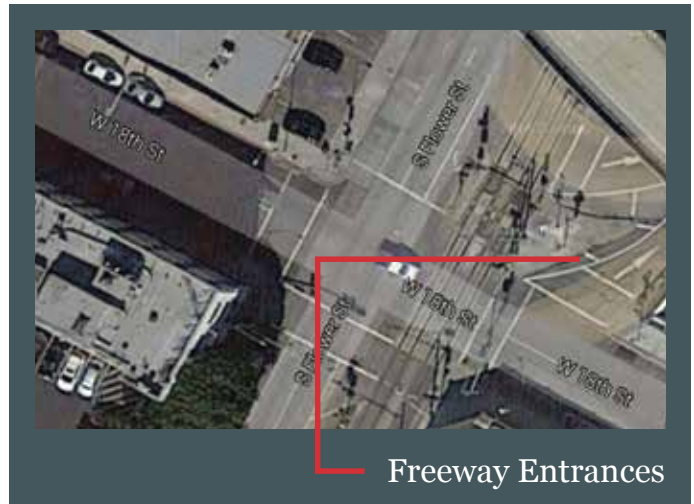
The intersection of South Flower Street and 18th Street is located within the Blue Line street running territory, and this intersection provides access to the Freeway Entrance for southbound traffic on Flower Street. Records provided by Metro indicate that 16 accidents occurred at this intersection between 2005 and 2014, resulting in injuries and one fatality.

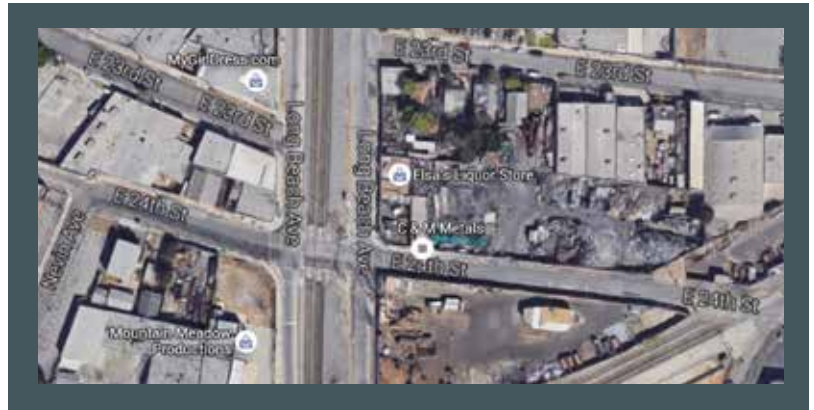
This intersection is located within the dedicated right-of-way on the Blue Line. In January 2015, a train fatally struck a pedestrian at the intersection.

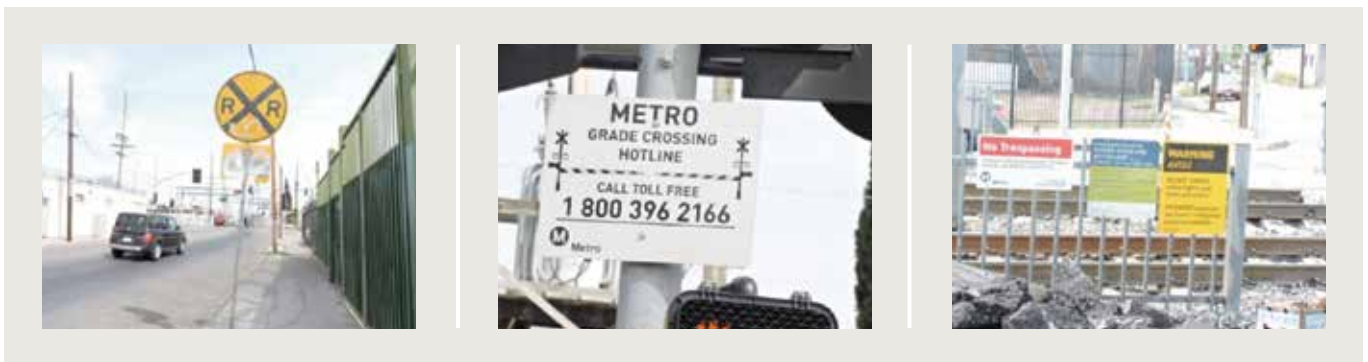
Signage

There are a number of pedestrian and vehicle signs that are not provided at this intersection. These includes:

- No vehicle on track sign,
- No pedestrian sign, and
- “Stop here when flashing” sign.

Further, a number of signs at this intersection are covered with graffiti.

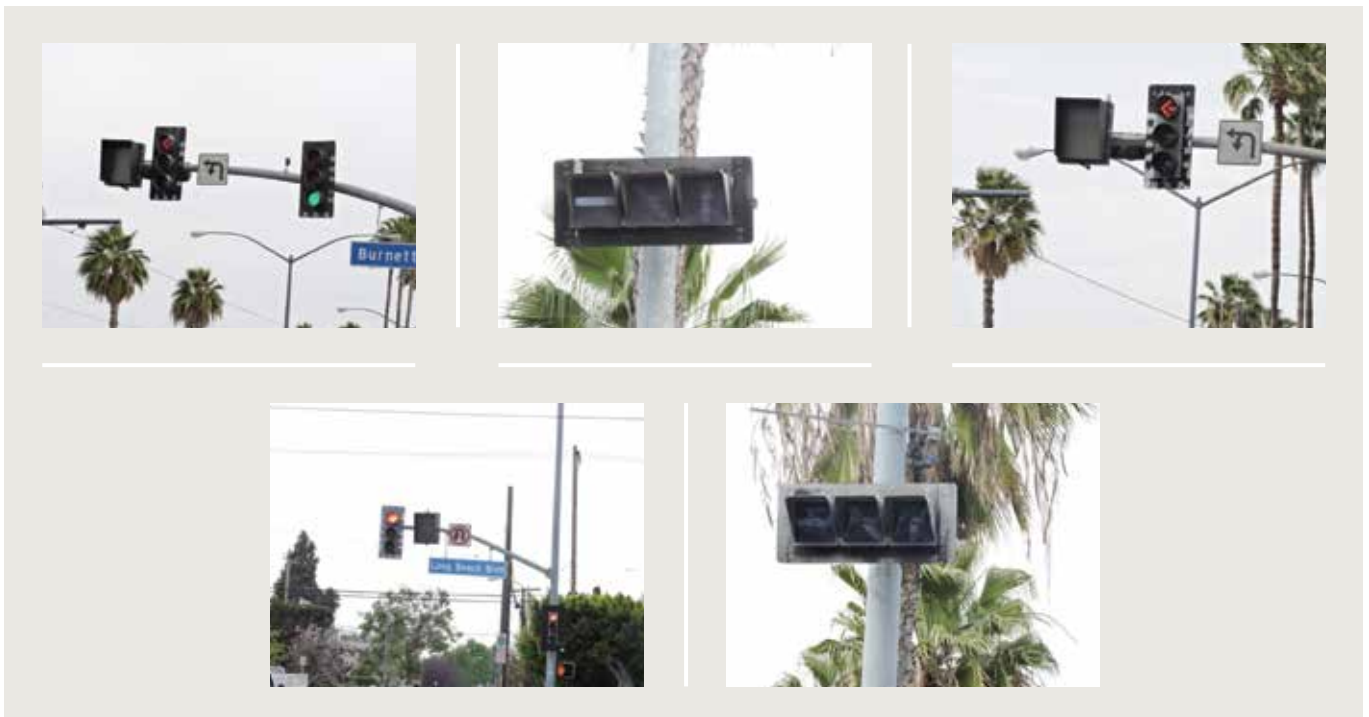
Traffic Equipment

Traffic signals are provided at the intersection to control the movements of vehicles, trains and pedestrians. A multi-phased traffic controller controls traffic signal aspects as well as the bar signals for trains. Pedestrian signals are activated manually via push buttons.

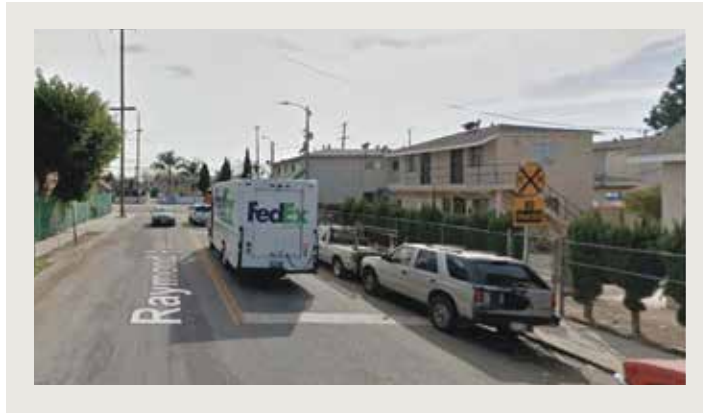
This intersection has all the basic pedestrian and vehicle signs.

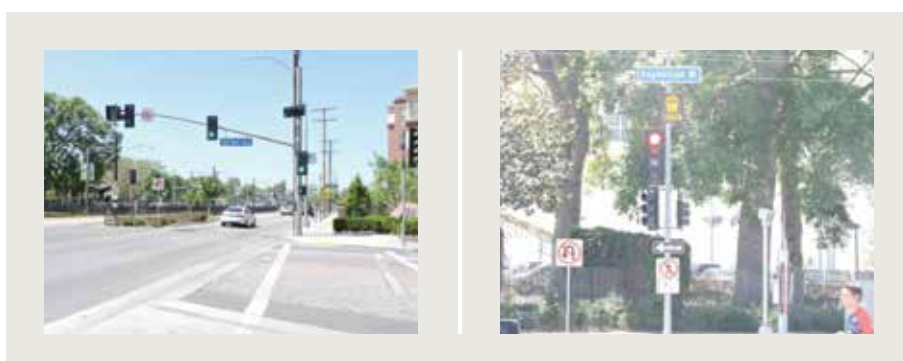
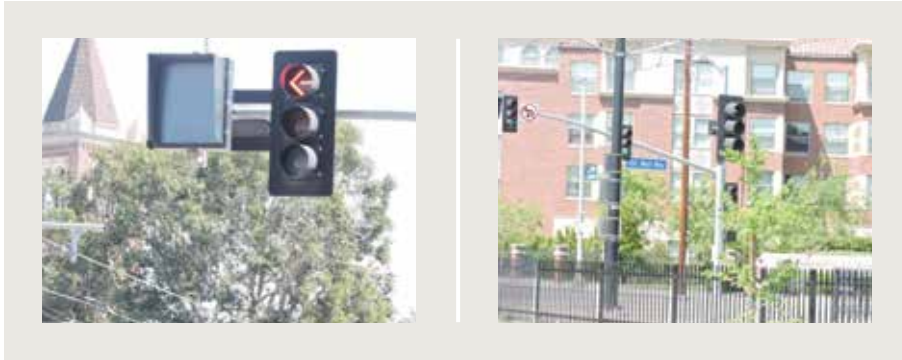
Traffic Equipment

Traffic signals are provided at the intersection to control the movements of vehicles, trains and pedestrians. A multi-phased traffic controller controls traffic signal aspects as well as the bar signals for trains. Pedestrian signals are activated manually via push buttons.

Photo enforced monitoring of traffic signals is provided.

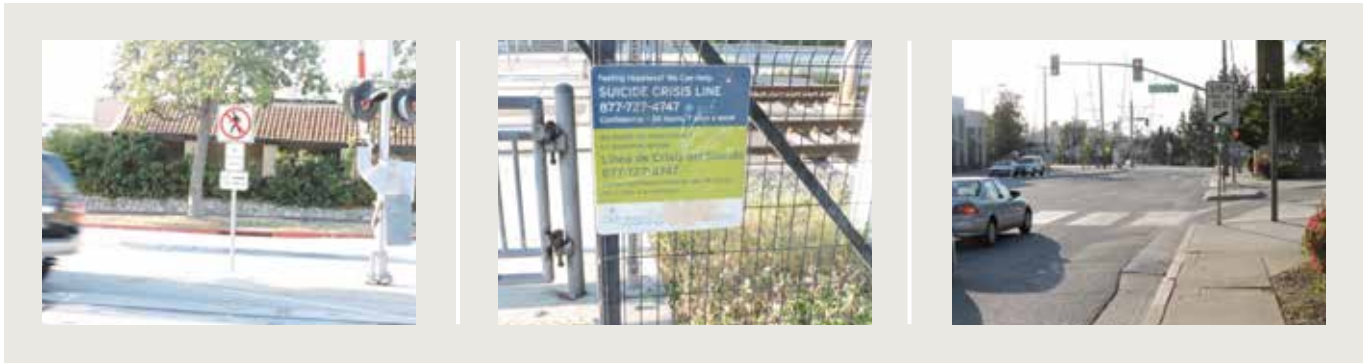
This intersection includes most of the basic vehicle and pedestrian signs, with the exception of the skewed crossing sign.

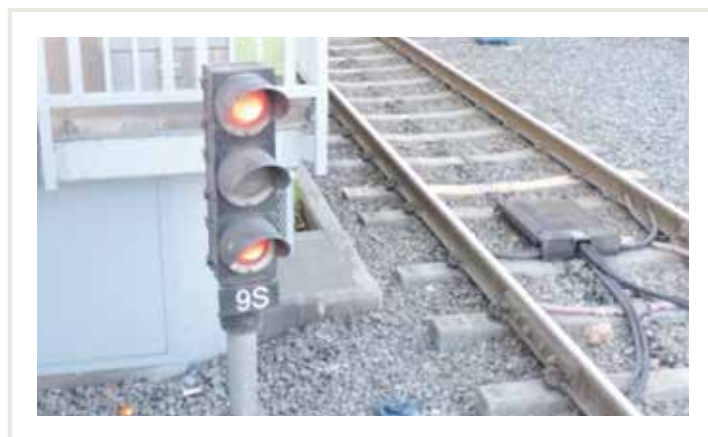
- Signal 9S is installed at the entrance to the station. Its function is to control the movement of a train into the station. It normally displays a FG/R (Flashing Green over Red) if there is no train at the platform. If a train is berthed at the platform, signal 9S displays R/R (Rule 3082). Also, this signal is located at the boundary between street running and ATP (cab-signaling) territory. There is a sharp curve in the approach to the signal, which results in a short sighting distance for the signal. Further, there is no enforcement at this signal, and safety of operation depends entirely on compliance with operating rules and procedures.

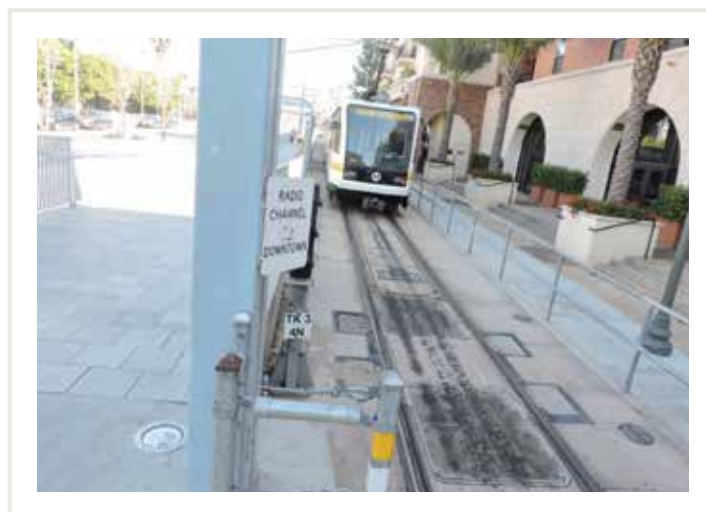
The Stop Signal Working Group did identify the curve in the approach to Signal 2S as a potential contributor to red signal violation. It was indicated that it is difficult to see the signal from 500 feet. However, the signal representative indicated that there is a restricted speed approaching the station, and train operators should be slowing down.
