Board Report

SUBJECT: OFFICE OF THE INSPECTOR GENERAL REPORT ON REVIEW OF METRO SAFETY CULTURE AND RAIL OPERATIONAL SAFETY

Attachment A - Report on Review of Metro Safety Culture and Signal Violations

LA Metro Safety Culture and Rail Operational Safety Review

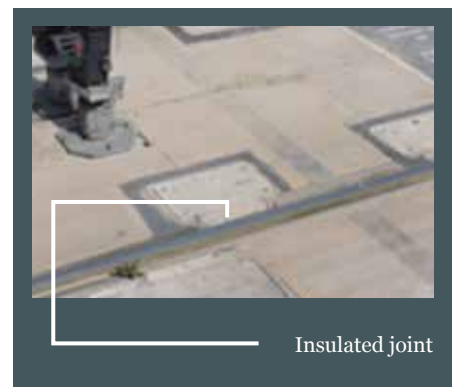
There is a lack of standards regarding the configuration of signal equipment at a signal location. For example, the relative location of the signal head versus the location of the insulated joint. On the Gold Line, insulated joints are located in advance of the signal head. However, on the Expo Line insulated joints are located after the signal head. It is important to establish an installation standard for insulated joints relative to the location of associated signal to ensure proper operation. A misplaced insulated joint could result in the cancellation of a signal in front of a train.

There is a lack of standardization regarding signal aspects and associated operating rules. Metro plans to modify the existing signal aspects on the Blue Line (Green/Red aspects) to be compatible with the signal aspects on the Gold Line (Green/Yellow/Red aspects).

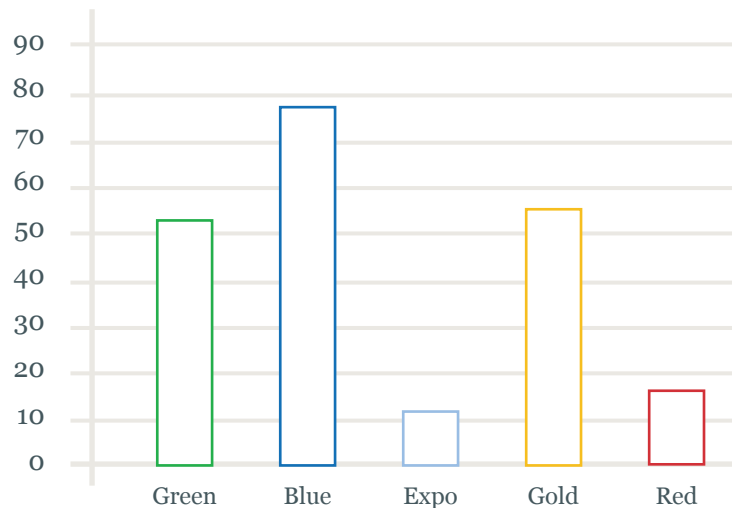
Metro Line	Total Failures	Characteristics
Blue	79	<ul style="list-style-type: none"> • Oldest signal installations - placed in service in July 1990 • 22 miles • Cab-signaling • Street running sections
Expo	12	<ul style="list-style-type: none"> • Newest signal installation - placed in service in April 2012 • 8.6 miles • Cab-signaling • Street running sections
Gold	55	<ul style="list-style-type: none"> • Placed in service in July 2013 • 31 miles • Cab-signaling distance to-go • Street running sections
Green	53	<ul style="list-style-type: none"> • Placed in service in April 1995 • 20 miles • Cab-signaling distance to-go • High level of automation • Dedicated right-of-way
Red	16	<ul style="list-style-type: none"> • Placed in service in January 1993 • 17.4 miles • Cab-signaling • Heavy rail installation

The following chart shows the distribution of signal failures for the various Metro lines:

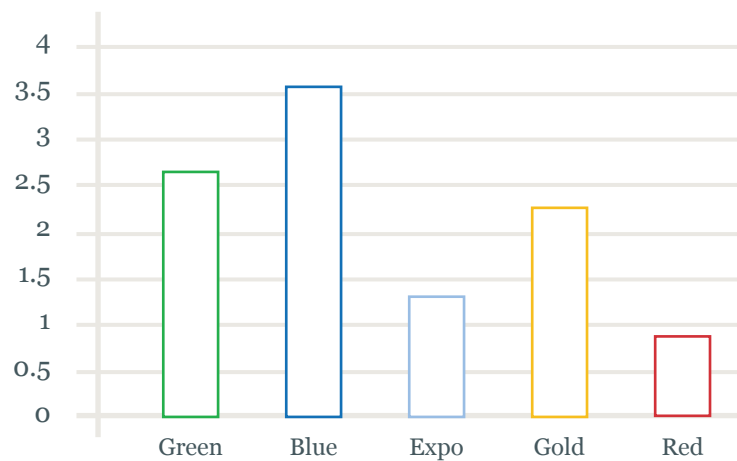
Metro Line	Total Failures	Track Miles	Failure/Mile
Blue	79	22.0	3.59
Expo	12	8.6	1.40
Gold	55	31.0	1.77
Green	53	20.0	2.65
Red	16	17.4	0.92

The following graph shows a failure per track mile distribution:

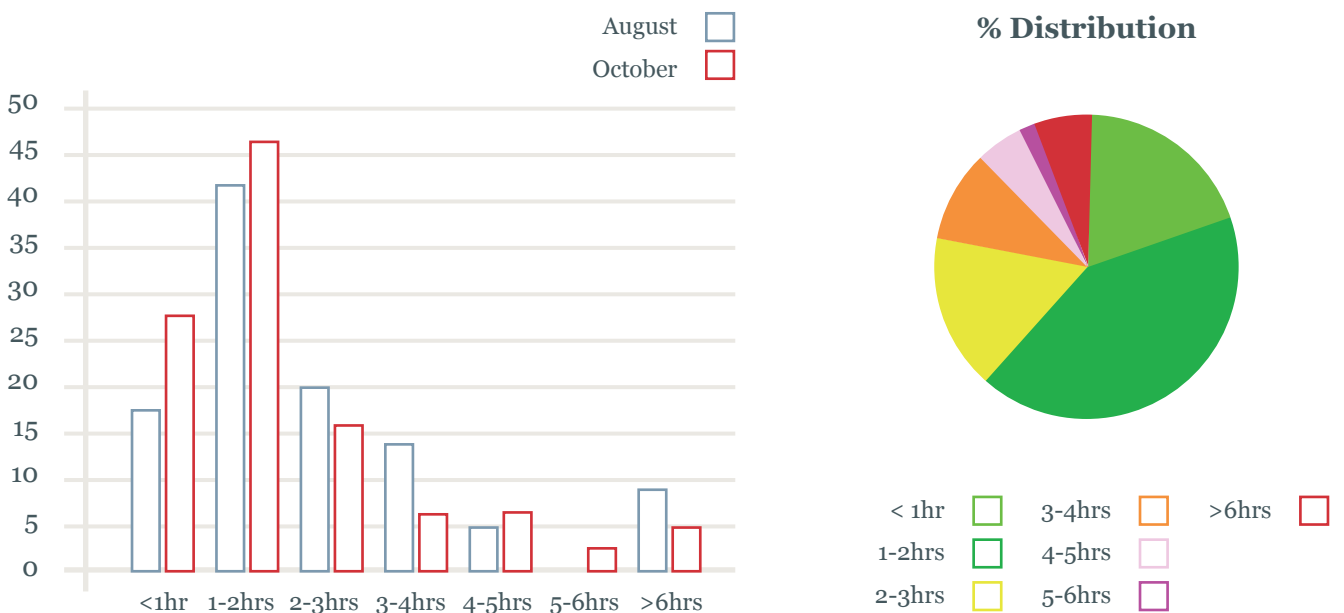
TTR	< 1 Hr.	1-2 Hrs.	2-3 Hrs.	3-4 Hrs.	4-5 Hrs.	5-6 Hrs.	> 6 Hrs.
Freq	42	88	36	21	11	3	12
%	19.7%	41.3%	16.9%	9.9%	5.2%	1.4%	5.6%

The above TTR distribution shows that approximately 78% of all signal failures are repaired within 3 hours, including travel time. It is difficult to compare TTRs for various transit properties as many parameters affecting TTR vary from property to property. Metro has not provided TWG with performance metrics related to signal maintenance efforts.

Approximately 5.6% of the incidents have a TTR in excess of six hours. A review of these incidents indicates that the associated signal failures required replacement of signal equipment and adjustments and/or troubleshooting intermittent failures, all of which are normally time consuming tasks.

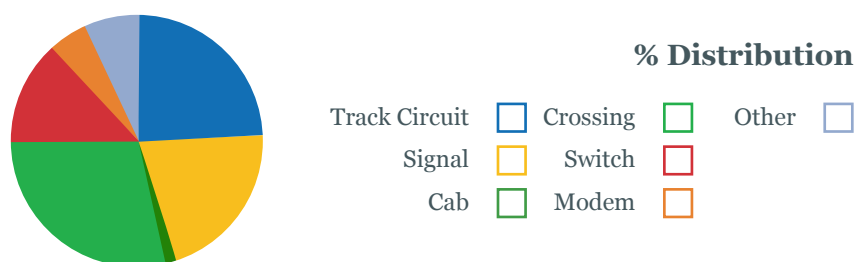
Failure Type	Track Circuit	Signal	Cab	X-ing	Switch	Modem	Other
Frequency	55	39	2	64	27	6	22
%	25.6%	18.1%	0.9%	29.8%	12.6%	2.8%	10.2%

The above distribution shows that over 70% of signal failures are caused by conventional signal equipment including track circuits, signals and grade crossing devices. This demonstrates the advantage of new train control technologies that minimize the use of conventional signal equipment.

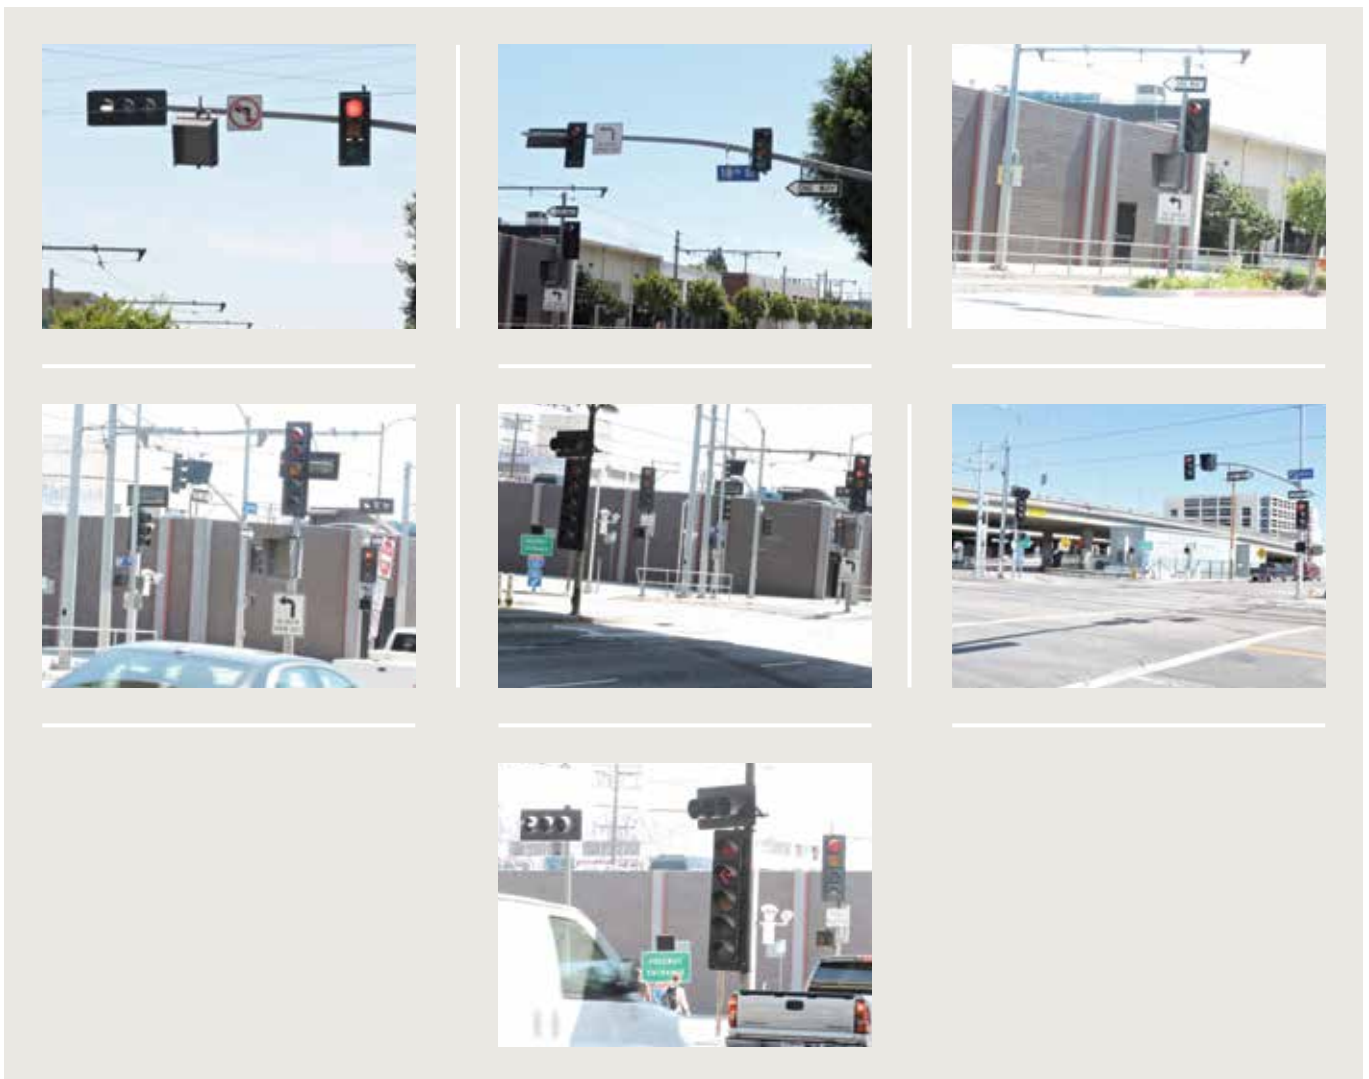
Traffic Equipment

Traffic signals are provided at the intersection to control the movements of vehicles, trains and pedestrians. A multi-phased traffic controller controls traffic signal aspects as well as the bar signals for trains. Pedestrian signals are activated manually via push buttons.

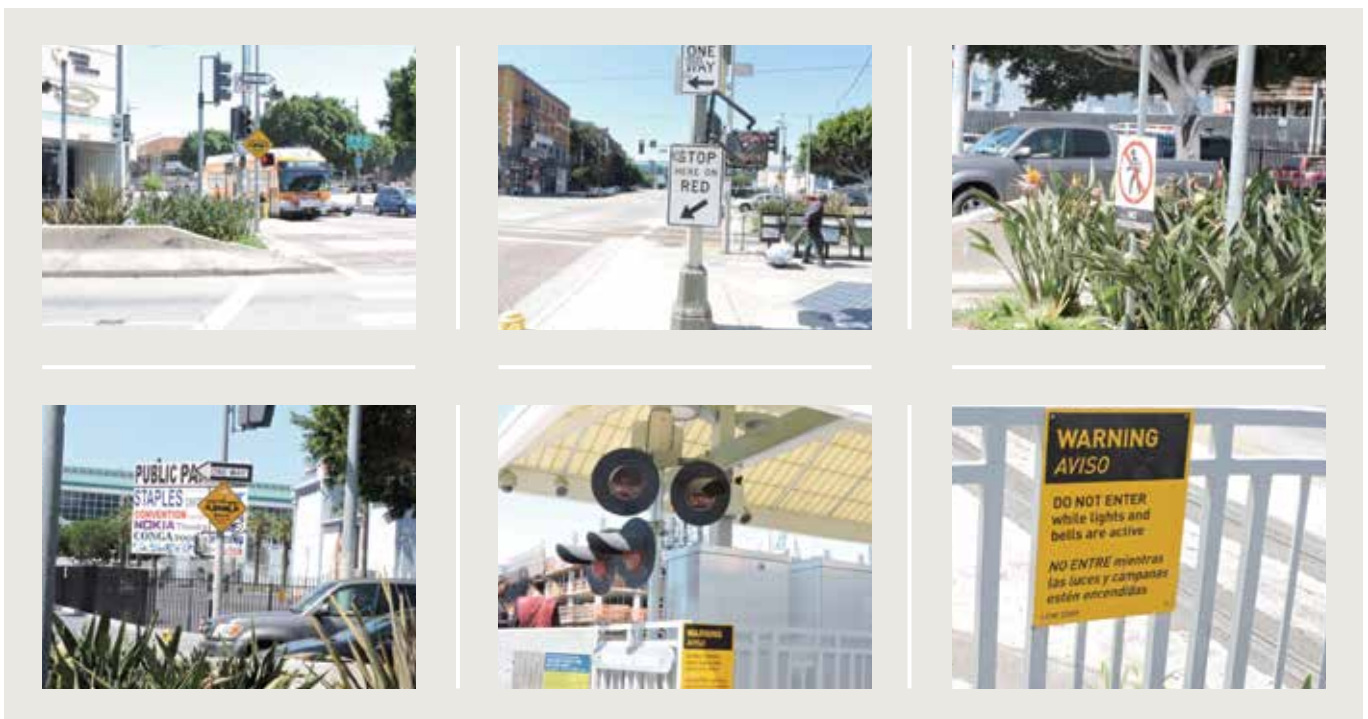
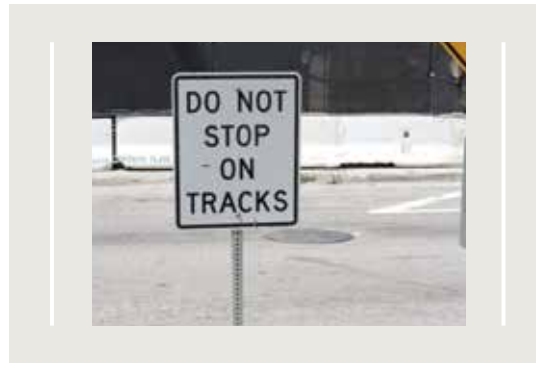
Signage

There are a number of pedestrian and vehicle signs that are missing at this intersection including:

- Advance warning signs, and
- No vehicle on track sign.

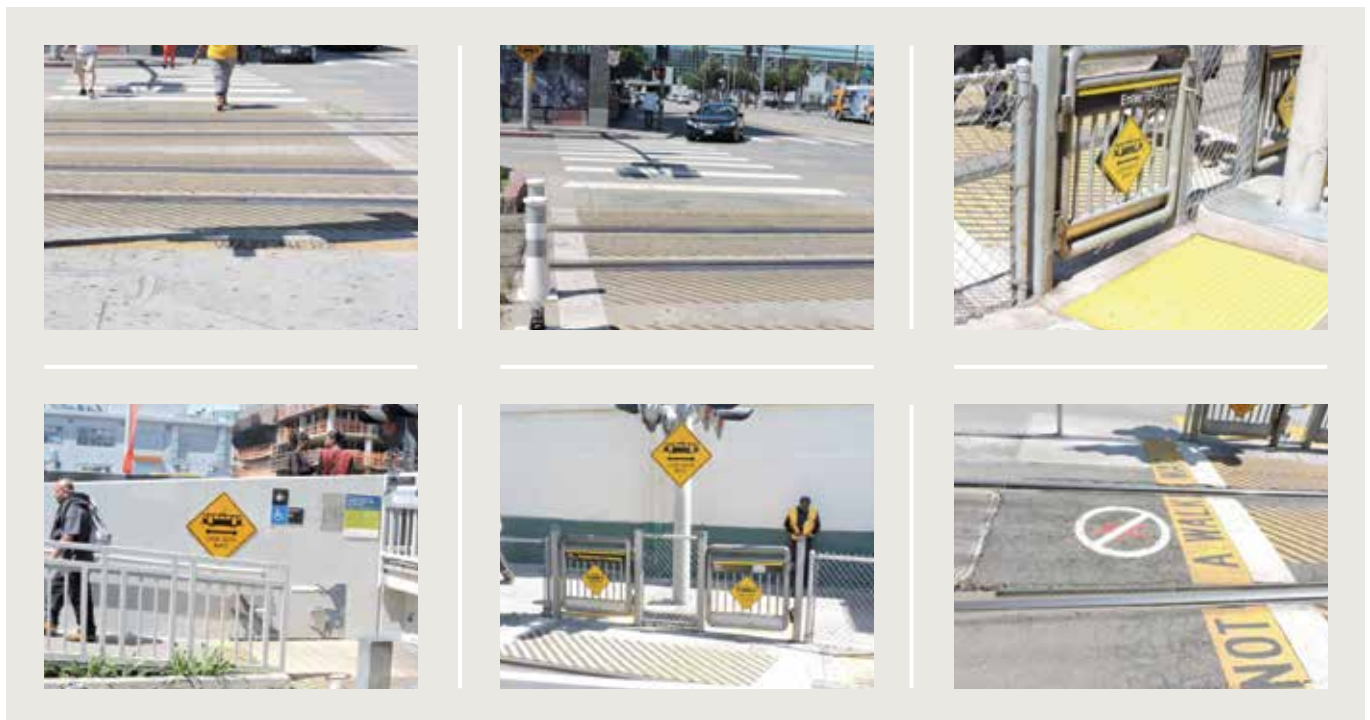
Street Markings

This intersection has good street markings to guide pedestrians through the crossing. Contrasting pavement color is provided to designate track areas. Pico Station also has pedestrian channelization with a barrier installed to guide pedestrians exiting from the station.

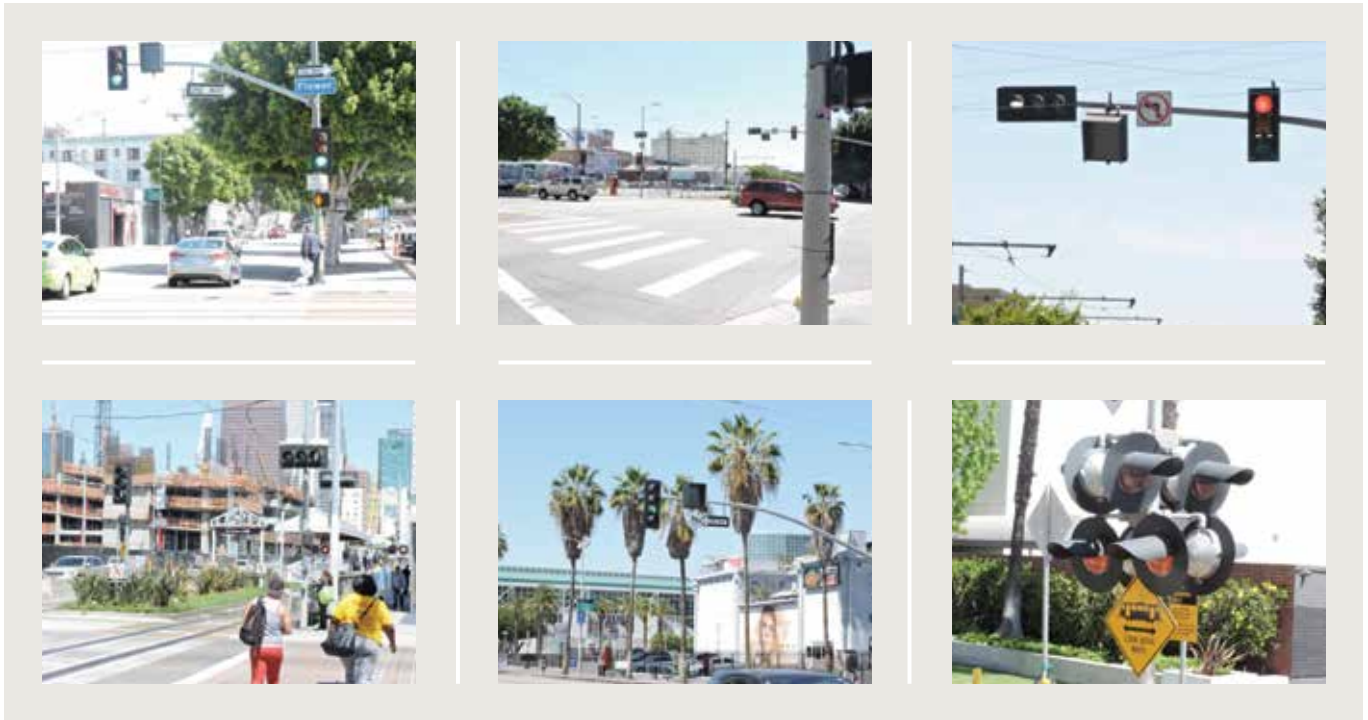
Traffic Equipment

Traffic signals are provided at the intersection to control the movements of vehicles, trains and pedestrians. A multi-phased traffic controller controls traffic signal aspects as well as the bar signals for trains. Pedestrian signals are activated manually via push buttons. Pedestrian flashing warning lights and bells are installed at Pico Station.

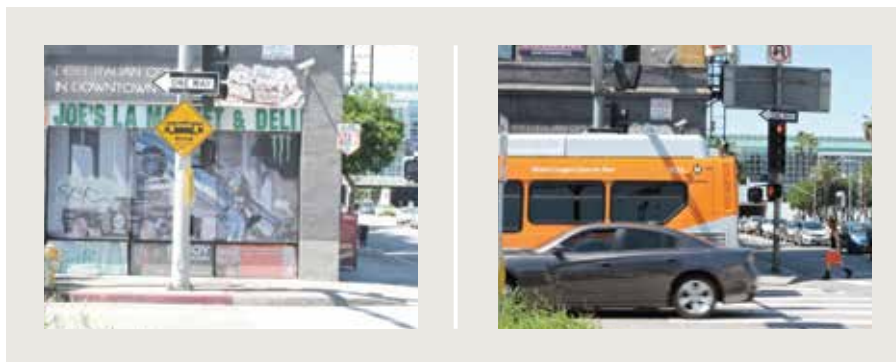
Other Issues

One of the “Look” signs is installed at a bus stop. When a bus makes a station stop, the sign is not visible.

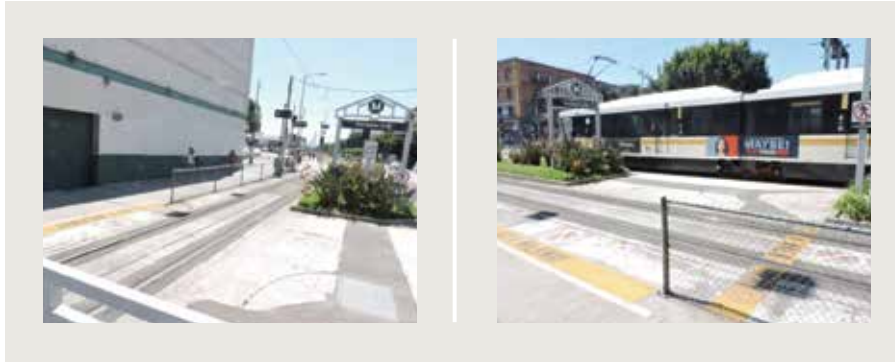
An unprotected private driveway exists at the south end of Pico Station. Based on the accident records provided by Metro, 12 accidents including one fatality occurred at driveways along Flower Street. The issue of unprotected private driveways was brought to the attention of Metro’s Corporate Safety to ascertain if Metro took actions to mitigate the risks associated with these driveways.

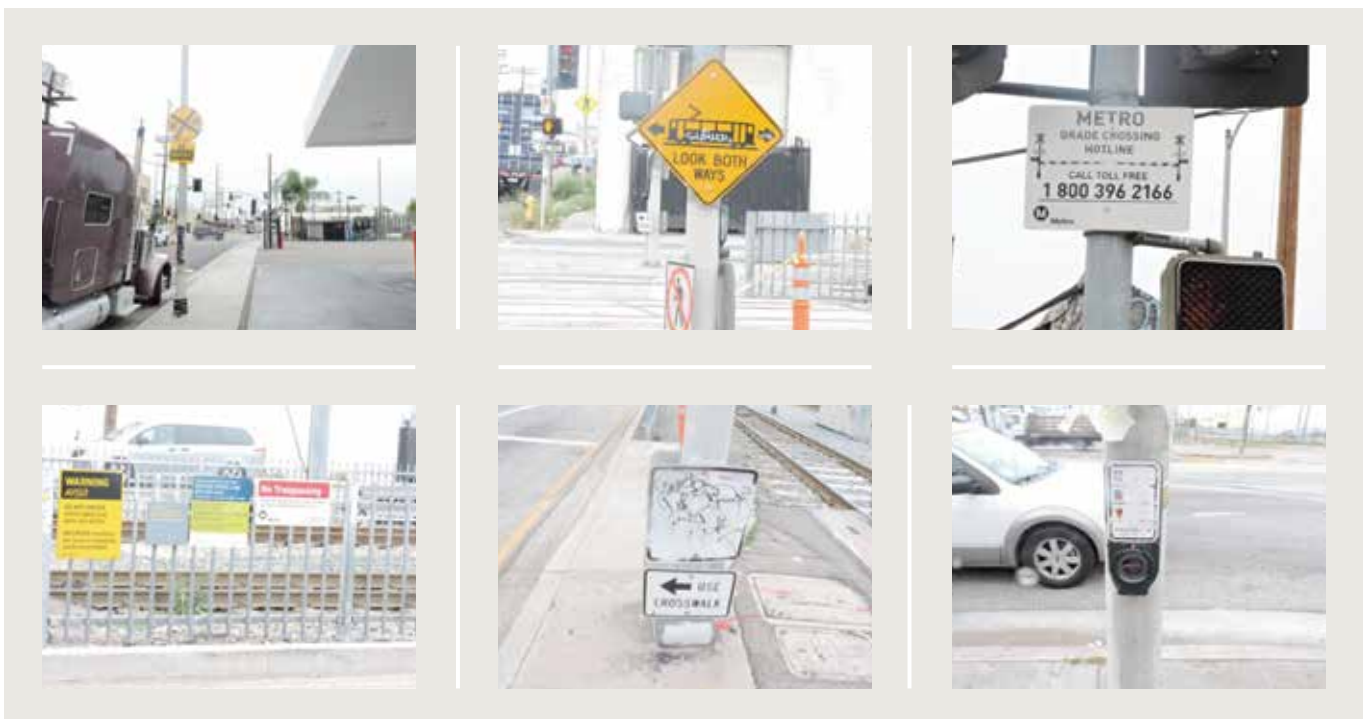
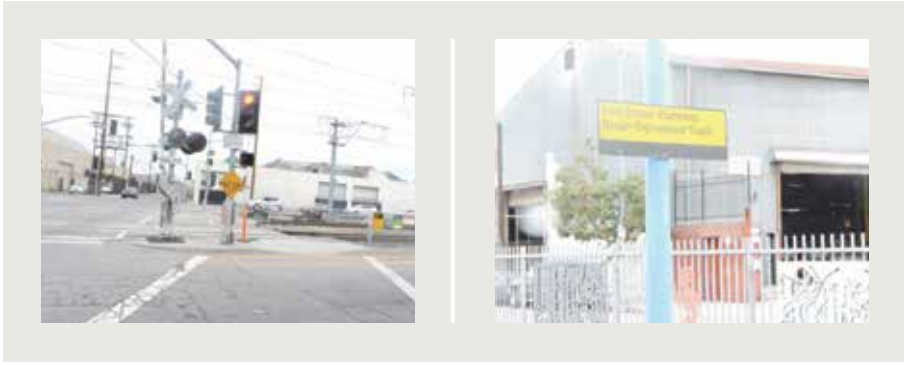
Signage

This intersection includes most of the basic vehicle and pedestrian signs, with the exception of the “No Vehicle on Track” sign and “Do not Stop on Track” sign.

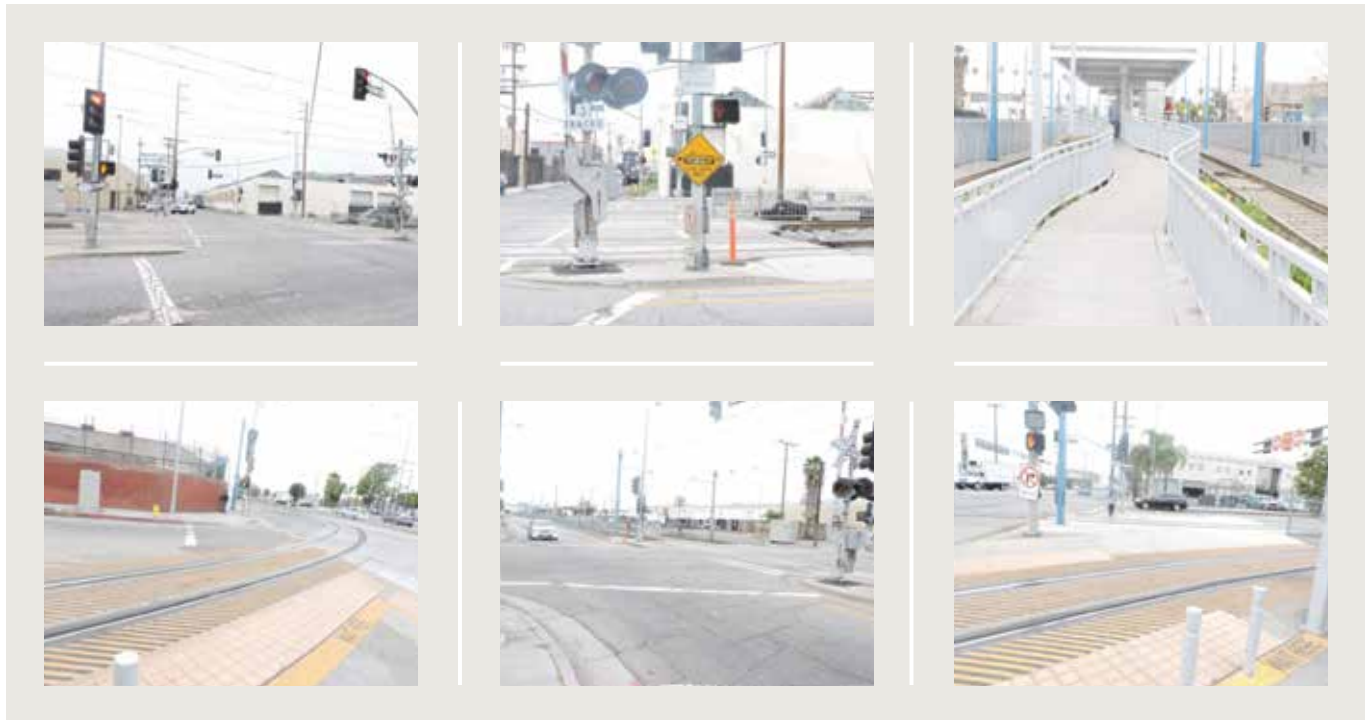
Street Markings

The 20th Street intersection (south end of Washington Station) does not have street markings or channelization to guide pedestrians through the crossing. Further, there is no street marking or treatment to mark the edge of the crossing. However, the north end of the station has channelization to guide pedestrians to exit the station. Further, street markings north of the station employ contrasting pavement color or texture for pedestrian crossings.

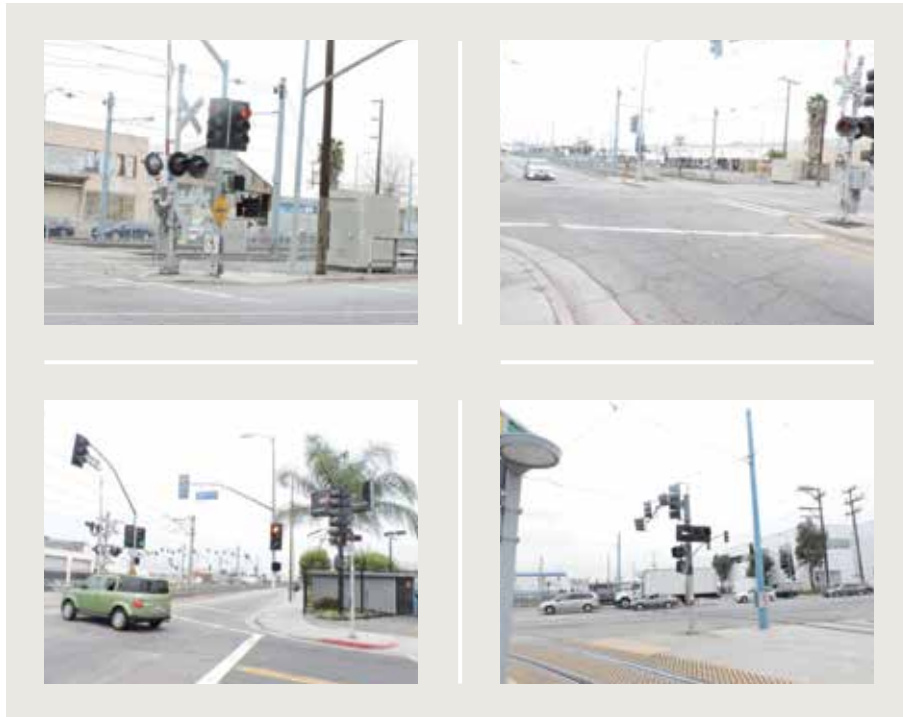
Traffic Equipment

The 20th Street intersection is equipped with basic crossing gates, flashing lights and bells for vehicles. There are no pedestrian flashing lights, gates or bells at this intersection. The only pedestrian crossing lights at this intersection are countdown lights that are manually activated by pedestrians.

Other than a sign for pedestrian to “Watch for Trains”, there is no other protection provided. Pedestrians are provided with a zone to wait for the clearing of the countdown crossing signals to clear. However, there are no provisions provided for pedestrians waiting between the tracks to activate the crossing signals.

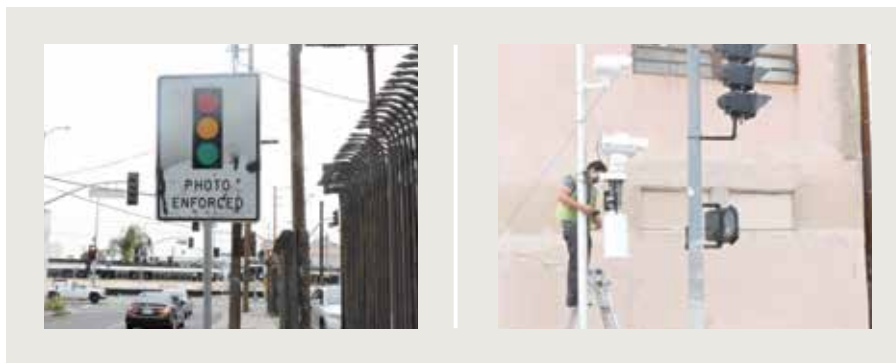
Traffic Enforcement

Photo enforcement is provided for traffic signals at the south end of Washington Station.

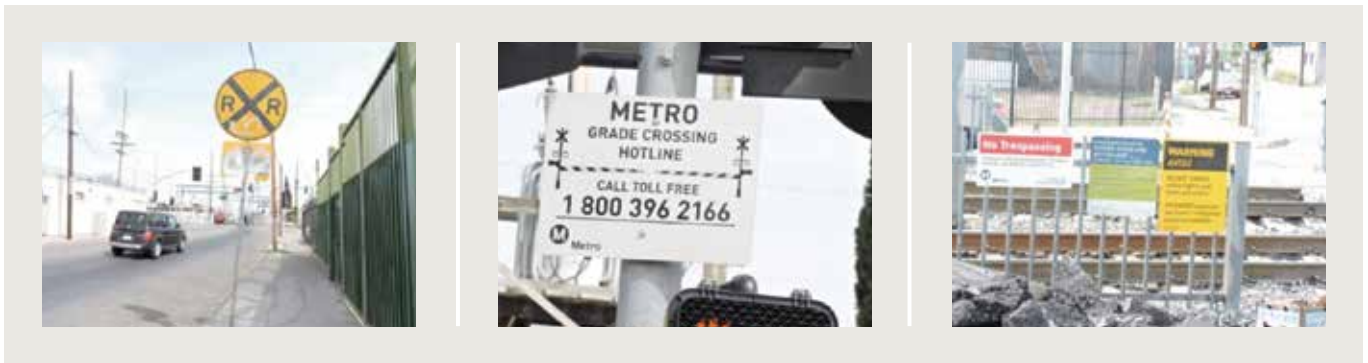
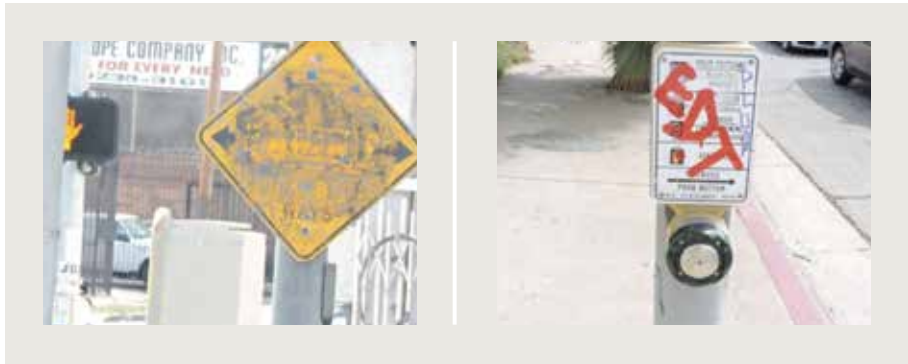
Signage

There are a number of pedestrian and vehicle signs that are not provided at this intersection. These includes:

- No vehicle on track sign,
- No pedestrian sign, and
- “Stop here when flashing” sign.

Further, a number of signs at this intersection are covered with graffiti.

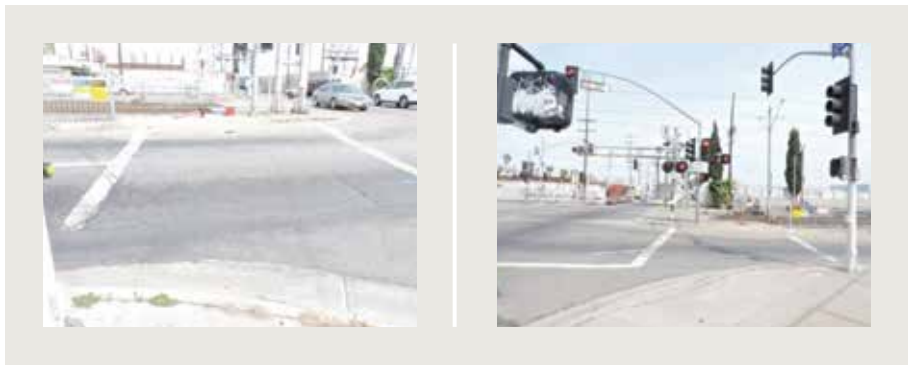
Street Markings

There are no street markings or channelization to guide pedestrians through the crossing. Further, there is no street markings or treatment to mark the edge of the crossing.

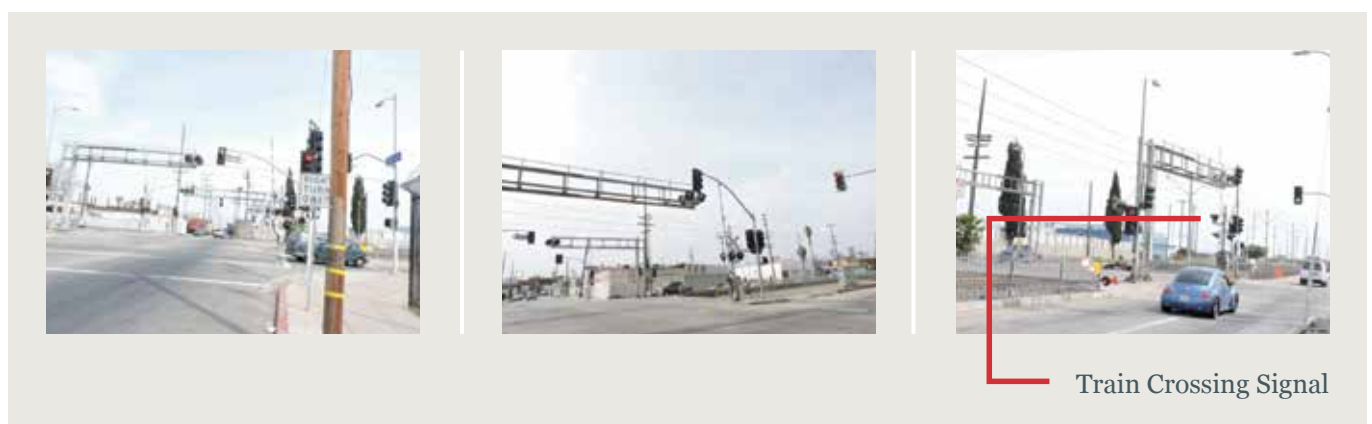
Crossing Equipment

This intersection is equipped with basic crossing gates, flashing lights and bells for vehicles. There are no pedestrian flashing lights, gates or bells at this intersection. The only pedestrian crossing lights at this intersection are countdown lights that are manually activated by pedestrians.

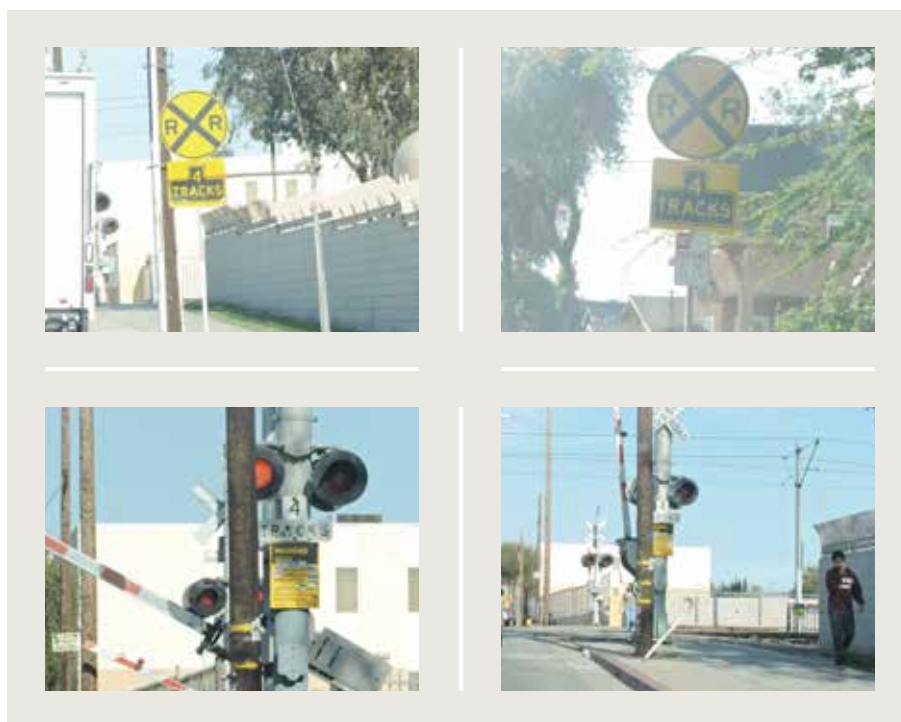
Signage

There are a number of pedestrian and vehicle signs that are not provided at this intersection. These include:

- Look signs,
- No vehicle on track sign,
- Emergency notification sign,
- No pedestrian sign, and
- “Stop here when flashing” sign.

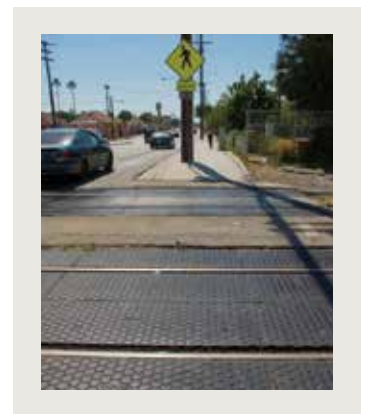
Street Markings

Crossing protection to pedestrians is only provided at one side of the intersection. There are no street markings or channelization to guide pedestrians through the crossing. Further, there is no street marking or treatment to mark the edge of the crossing.

To enhance the safety of operation at this location, it is essential to undertake measures that will discourage public unsafe behavior. This can be achieved through the installation of additional signs, street markings & traffic equipment, and by implementing a channelization scheme to guide pedestrians through the crossing. Further, the implementation of dynamic information related to approaching trains will inform the public when more than one train is approaching the intersection. A contributing factor to one fatality at this intersection is related to a second train that struck a pedestrian. Appendix 8 identifies a number of industry best practices to improve the safety at rail/vehicle intersections. The implementation of a number of these measures at this location will help achieve an environment that will encourage safe public behavior.

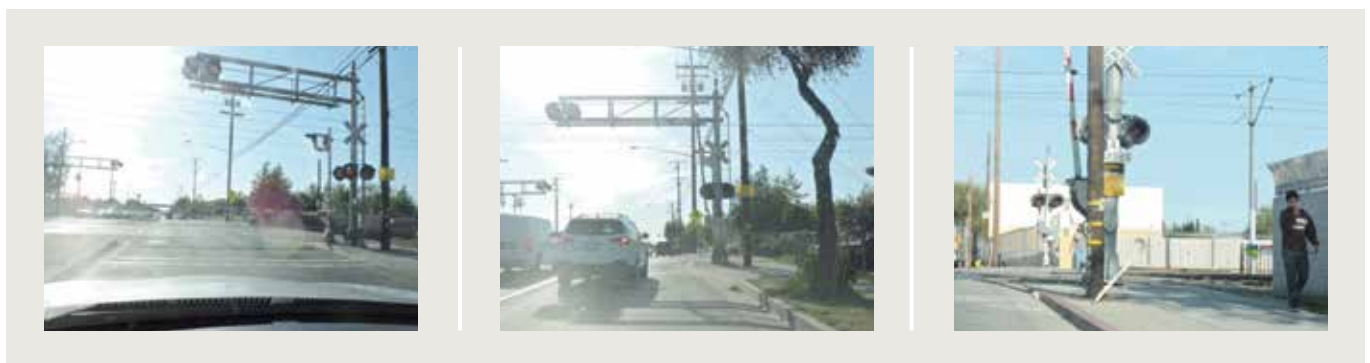
Traffic Equipment

This intersection is equipped with basic crossing gates, flashing lights and bells for vehicles. Pedestrian flashing lights, gates and bells are provided only at one side of the intersection.

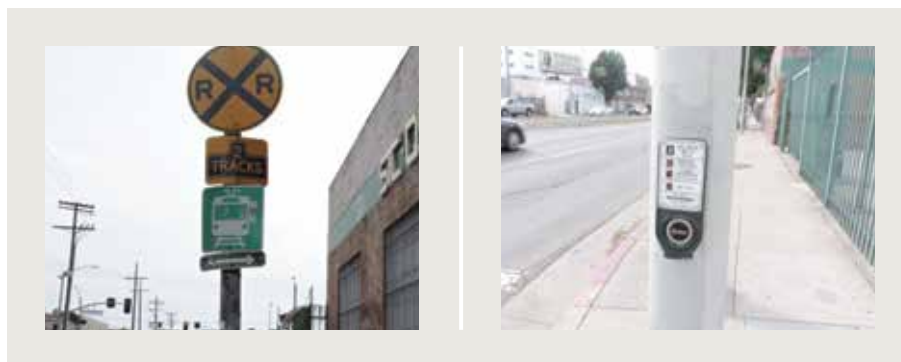
Signage

There are a number of pedestrian and vehicle signs that are not provided at this intersection. They include:

- Look sign,
- No vehicle on track sign,
- Stop here on red sign,
- “Suicide Crisis Line” sign,
- No pedestrian sign, and
- “Stop here when flashing” sign.

The main factor that contributed to prior accidents is unsafe behavior by the public in violating traffic signals. To enhance the safety of operations at this intersection, it is essential to undertake measures that will discourage unsafe public behavior. There is a need to focus on improving the signage and dynamic information provided to the public, as well as the implementation of traffic enforcement measures. Appendix 8 identifies a number of industry best practices to improve the safety at rail/vehicle intersections. Implementing a number of the identified measures will help achieve an environment that encourages safe public behavior.

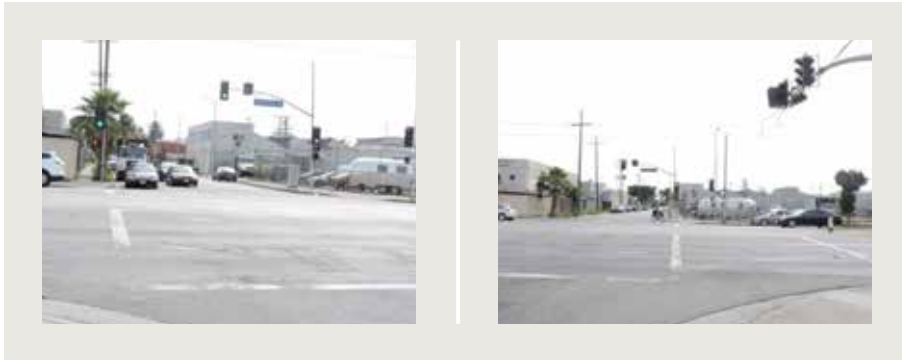
Street Marking

There are no street markings or channelization to guide pedestrians to cross the tracks, and pedestrian street markings are fading and need to be repainted.

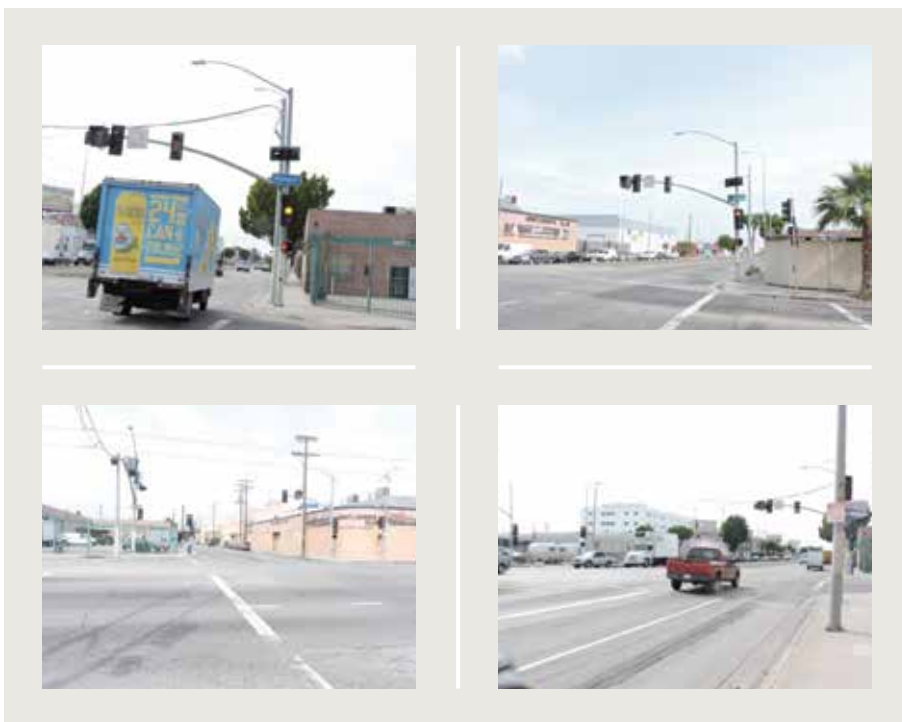
Traffic Equipment

Traffic signals are provided at the intersection to control the movements of vehicles, trains and pedestrians. A multi-phased traffic controller controls traffic signal aspects as well as the bar signals for trains. Pedestrian signals are activated manually via push buttons.

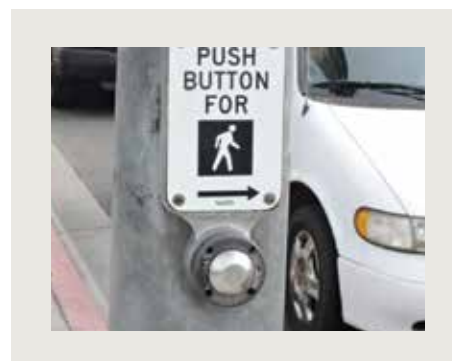
Signage

There are a number of pedestrian and vehicle signs that are missing at this intersection. They include:

- Advance warning signs,
- Look signs,
- No vehicle on track sign,
- No pedestrian sign,
- Do not stop on track sign,
- Stop here on red sign, and
- Suicide crisis line sign.

- Installation of blank out no left turn sign,
- Installation of a second train signal to advise motorists and pedestrians that two trains are approaching an intersection,
- Installation of illuminated active in-pavement marking (IPM) systems, and
- Installation of traffic enforcement devices.

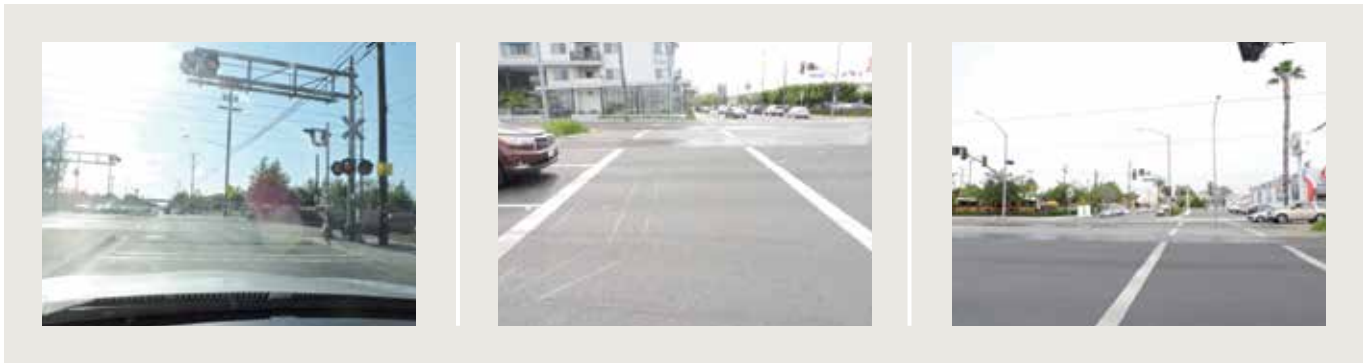
Street Markings

There are no street markings or channelization to guide pedestrians through the crossing. Further, there is no street marking or treatment to mark the edge of the crossing.

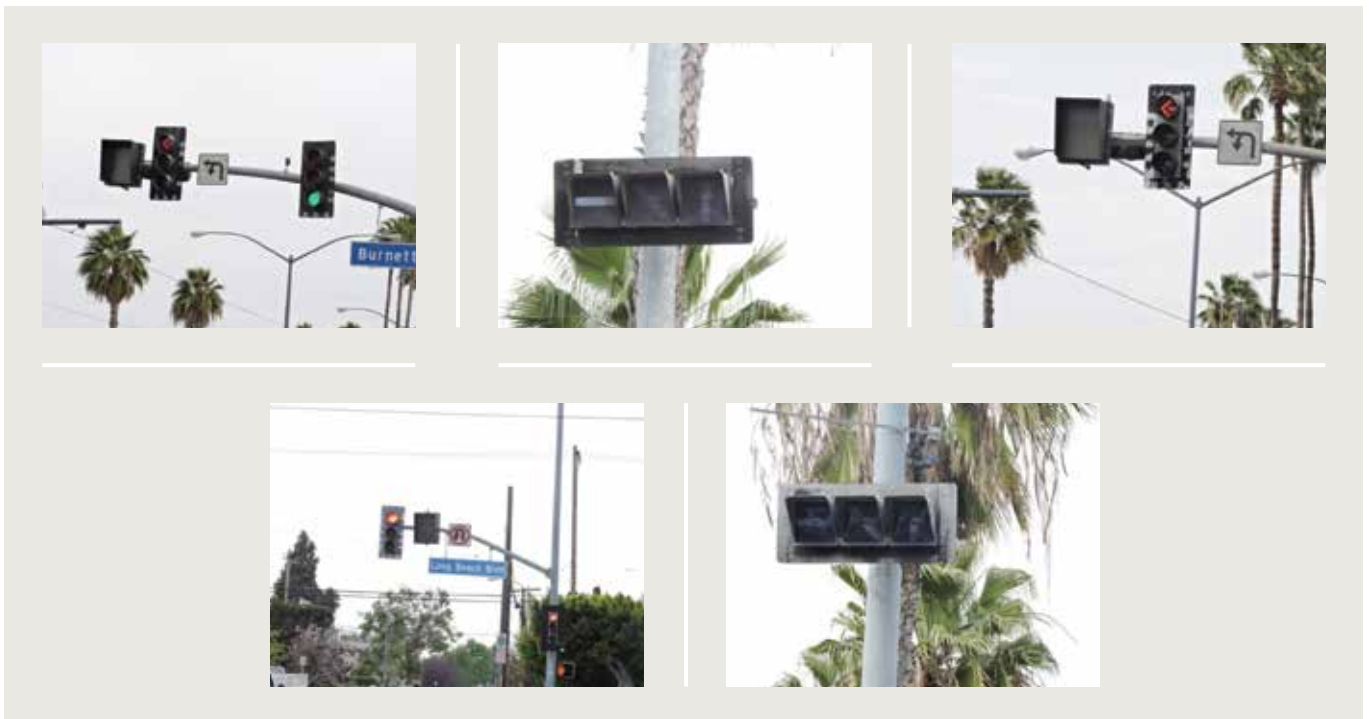
Traffic Equipment

Traffic signals are provided at the intersection to control the movements of vehicles, trains and pedestrians. A multi-phased traffic controller controls traffic signal aspects as well as the bar signals for trains. Pedestrian signals are activated manually via push buttons.

All three accidents occurring at this intersection are due to a vehicle making an illegal left turn with a train approaching the intersection.

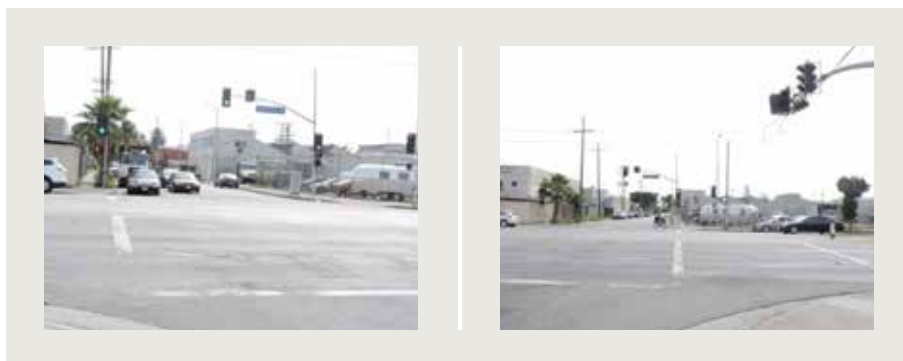
Traffic Monitoring Equipment

Traffic signals at this intersection are photo enforced.

- Installation of blank out no left turn sign,
- Installation of illuminated active in-pavement marking (IPM) systems.

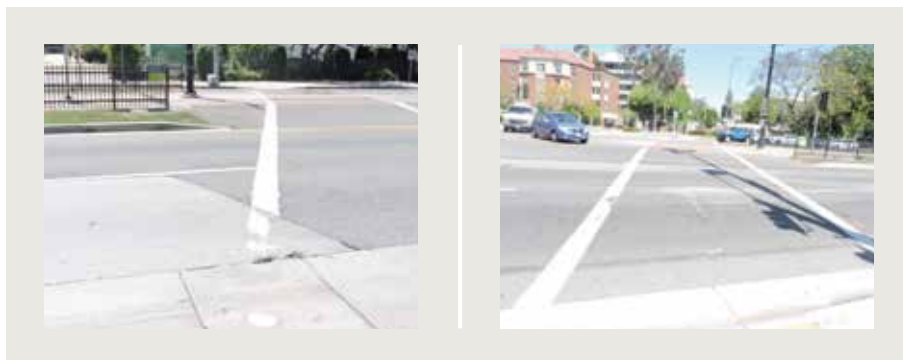
Street Markings

There are only fading white lines to mark the pedestrian crossing. There is no channelization to guide pedestrians through the crossing.

- Installation of blank out no left turn sign,
- Installation of a second train signal to advise motorists and pedestrians that two trains are approaching an intersection and
- Installation of illuminated active in-pavement marking (IPM) systems.

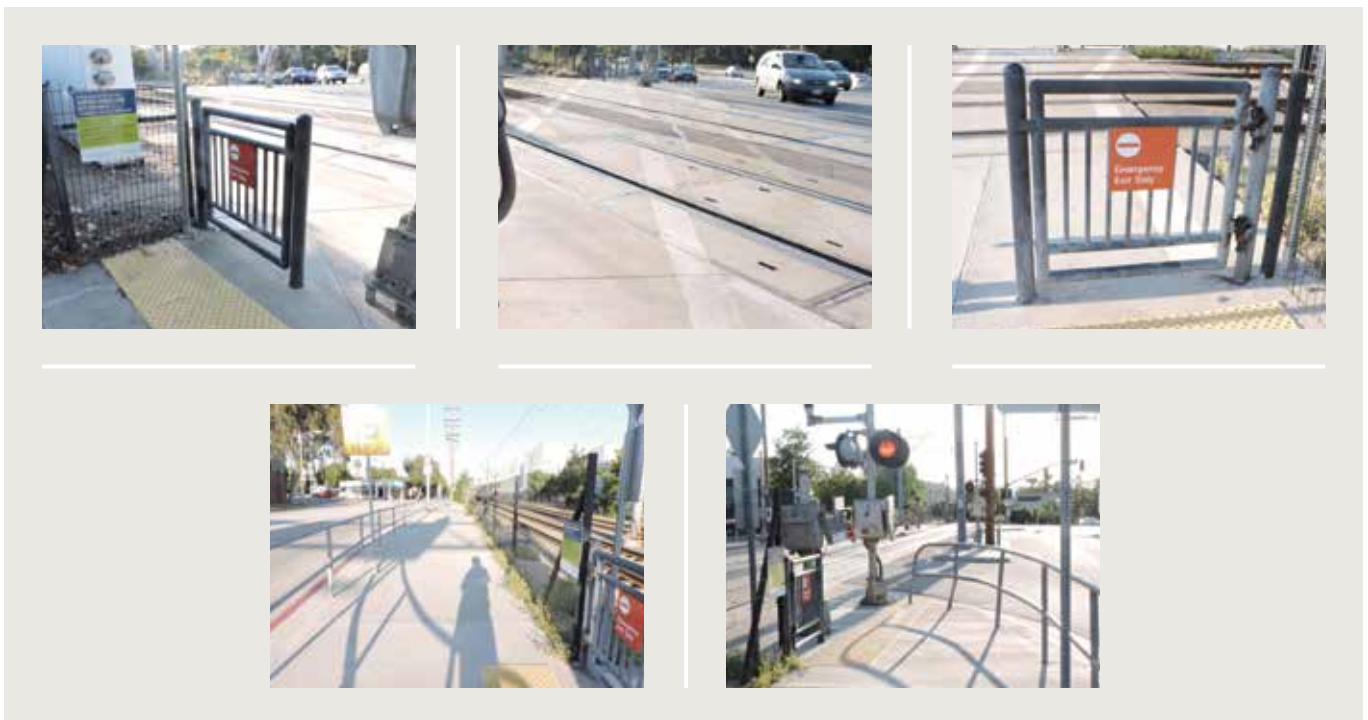
Street Markings

Adequate crossing protection is provided to pedestrians, including channelization to guide pedestrians through the crossing and swing gates. However, street markings within the intersection are fading away.

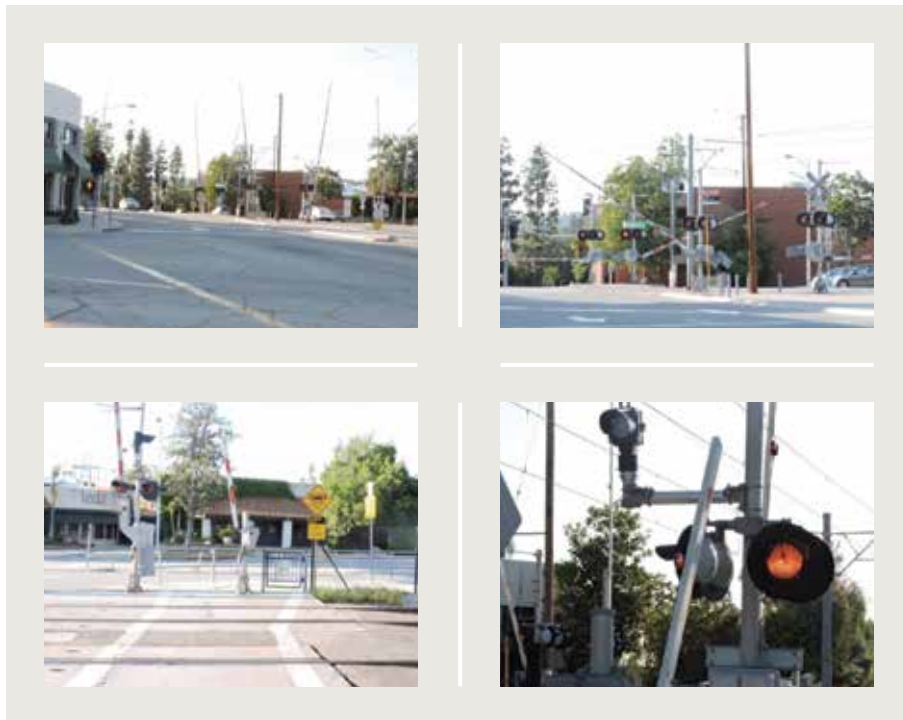
Traffic Equipment

This intersection is equipped with a Four-Quadrant gate system, including crossing gates, flashing lights and bells for vehicles. Pedestrian flashing lights, gates and bells are also provided.

The two prior accidents at this intersection are attributed to trespassing by pedestrians. As such, the main contributing factor to the accidents is unsafe behavior on the part of the public.

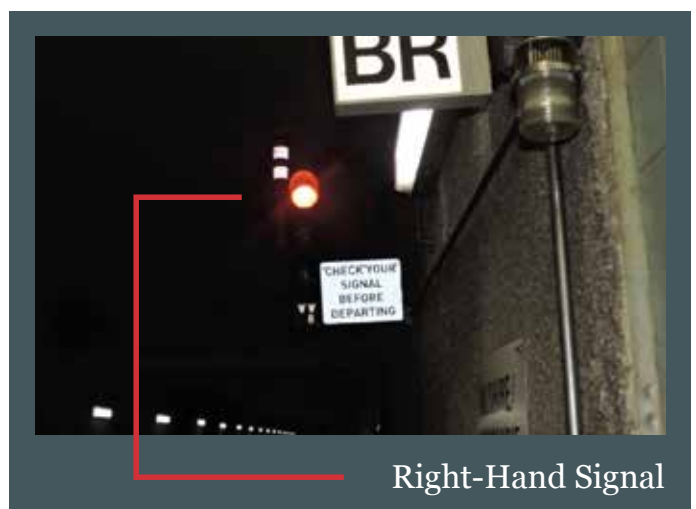
- Although Metro signal standards require signals to be installed on the left of the track, Signal 8 is a right hand signal,

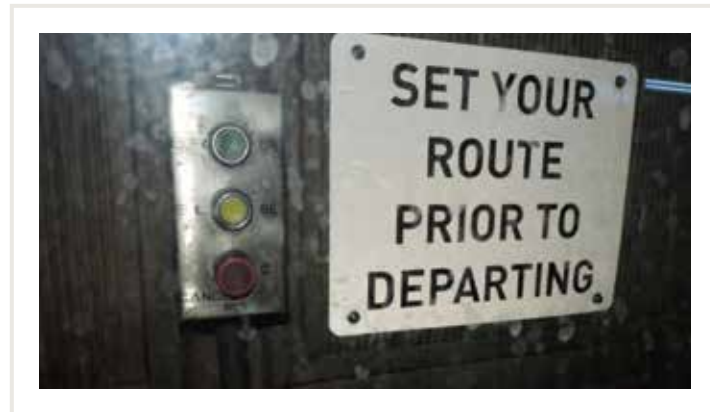
- The motorman pushbutton at the location does not include an indicator to inform the train operator if it is necessary to establish the route at the signal, and
