Board Report

SUBJECT: OFFICE OF THE INSPECTOR GENERAL REPORT ON REVIEW OF METRO SAFETY CULTURE AND RAIL OPERATIONAL SAFETY

Attachment A - Report on Review of Metro Safety Culture and Signal Violations

LA Metro Safety Culture and Rail Operational Safety Review

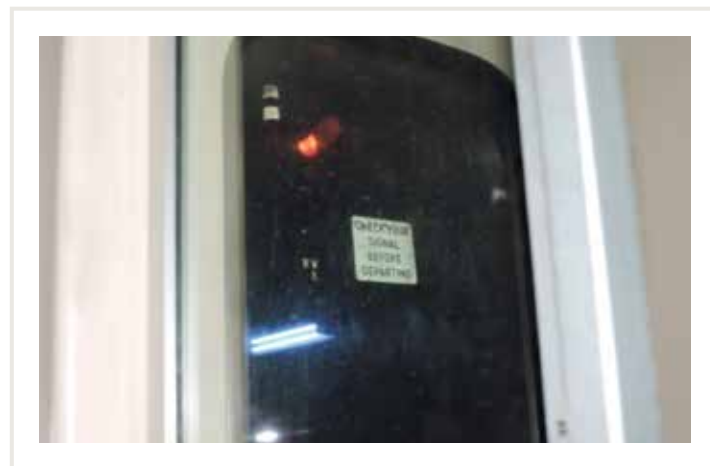
- When the train operator's cab is aligned with the motorman pushbutton location, Signal 8 is not visible from the train operator's position. The train operator needs to lean to the right side of the cab to see the signal.

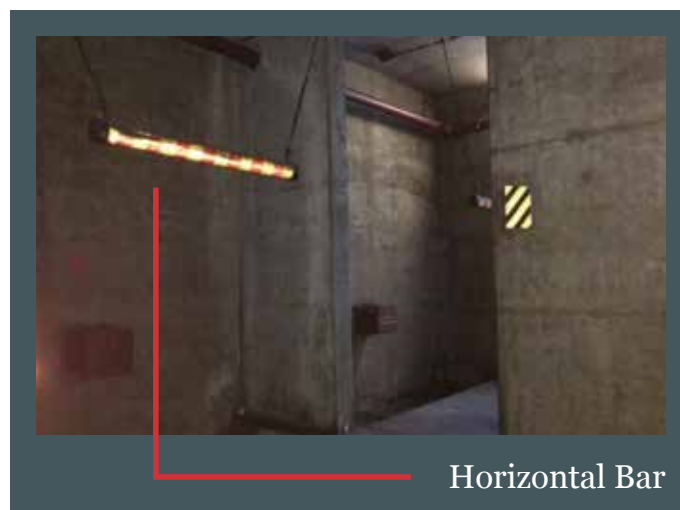
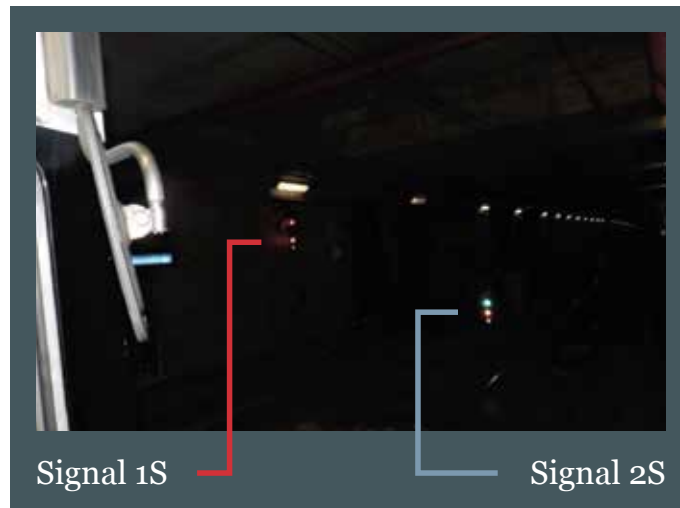
- Good visibility of signal 3N,
- There is a horizontal bar at the end of the tail track. Train operators are reluctant to stop the train at the horizontal bar, and some train operators stop a few feet short of the horizontal bar for fear of hitting the bump wall. This tight configuration makes it difficult for train operators to see Signal 4S, especially if the train stops a few feet from the horizontal bar, and
- Good visibility for Signals 1S & 2S.

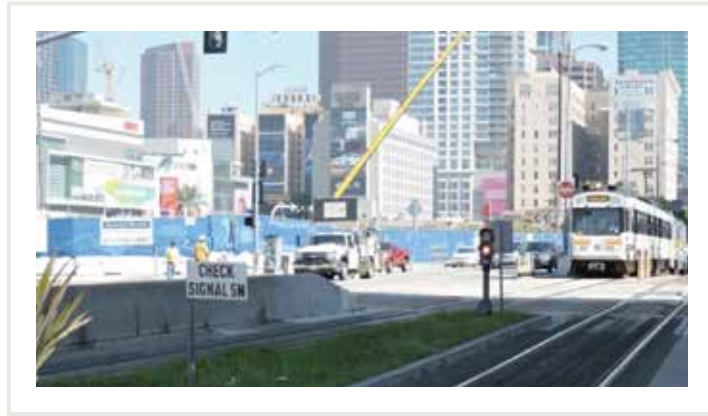
In view of the high number of violations at this signal location, our team conducted a number of interviews with Metro’s Operations personnel, and inspected the physical signal configuration to determine if there are other factors that contributed to the violations.

A review of the signal single line drawings shows that Signal 5N is located at least 50 feet south of the feed end for track circuit 15T. Further, the configuration of overlay track circuit 601AT does not detect a train crossing at Signal 5N. As such, it appears that Signal 5N will remain clear until the train reaches track circuit 15T, approximately for 50 FT past the signal location. Similarly, a train violating a stop aspect at 5N will not be detected for approximately 50 feet. Such operation is not desirable, and could be a contributing factor to red signal violation. The Blue/Expo Train Operator SOPs describes the procedure for operating in the approach to the portal, and specifically states that train operator will be governed by signal 5N. The SOPs then instruct the train operators to “Operate at 35 mph from Pico station until train is completely inside underground section”.

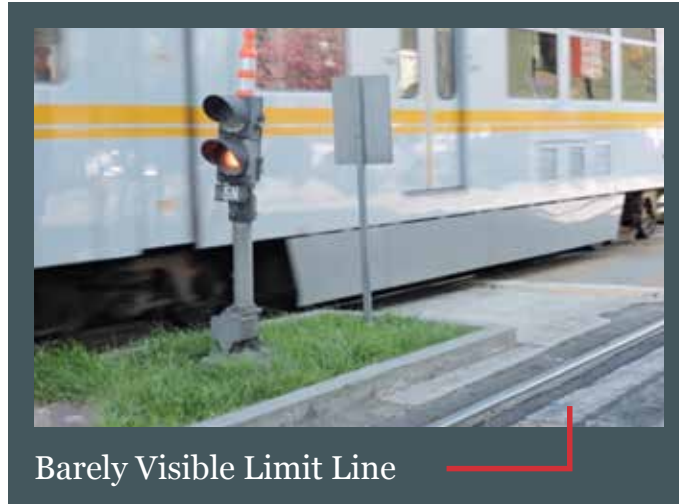
The Stop Signal Working Group identified the following issues at Signal 5N:

- The bar signal at the intersection changes very quickly,
- The Limit Line at the signal location is barely visible, and
- The signal remains “Green” until the train crosses the intersection.

While the Limit Line should be repainted, a violation of the limit line by itself does not register as a red signal violation because the controlling track circuit is located at least 50 feet north of the signal location. However, if the train stops past the limit line, then it will be difficult for train operator to see signal 5N. Upon the clearing of the bar signal at the intersection, and the movement of the train past the intersection, a red signal violation will register when the train passes the insulated joint for track circuit 15T.

With respect to a fast changing bar signal, this will not contribute to a violation. However, a clear bar signal at the intersection can distract train operators from paying attention to signal 5N. It should be noted that the APTA Peer Review Panel identified lack of coordination between bar signals and interlocking signals at an intersection a one of the contributing factors to violations.

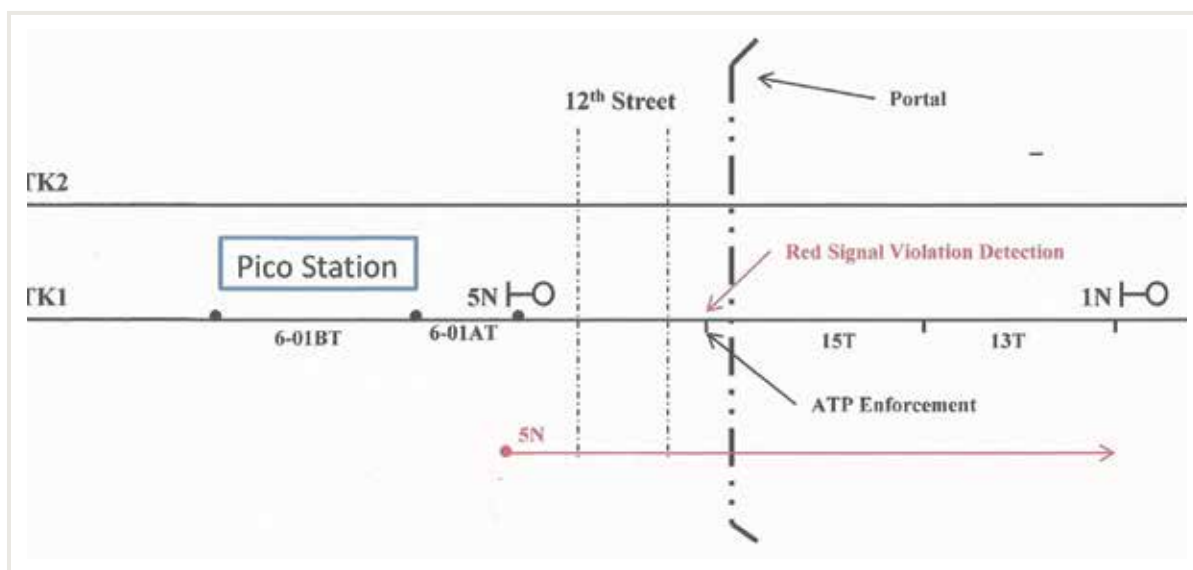
As indicated above, there is a risk of train to train collision at Signal 5N. The following simplified drawing shows the main elements of the signal configuration between Pico Station and interlocking signal 1N in the approach to 7th & Metro Terminal Station:

The factors that contribute to this safety hazard are summarized as follows:

- As indicated above, Signal 5N operates as an automatic signal (block signal control) to provide train separation for trains entering the portal. Signal 5N displays a “stop” aspect if either 15T or 13T is occupied.

- There is no enforcement at Signal 5N. However, ATP enforcement starts at 15T.
- During 2012 through 2015, there were 9 red signal violations at Signal 5N.

- A red signal violation at Signal 5N indicates that the violating train crossed the 12th Street intersection and reached 15T with a train still at the approach to Signal 1N.

In view of the finding of this safety hazard, TWG brought this issue to Metro's attention on April 10, 2016, and recommended that for Metro to issue a safety advisory instructing train operators to operate at a reduced speed in the approach to the portal. In response, Metro took immediate action to mitigate this hazard, including:

TWG further recommended to Metro to conduct a braking test that verifies the initial hazard condition and the mitigation implemented by Metro. In addition, TWG recommended for Metro to install a speed sign of 20 mph in the approach to the portal.

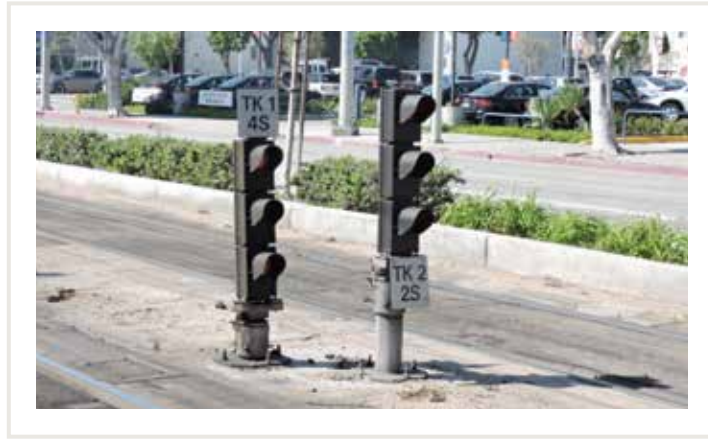
The site visit revealed that signals 2S and 4S have good visibility. However, these southbound signals are installed side-by-side, which is contradictory to basic training provided to train operators.

Similar operating conditions exist at northbound signals 2N & 4N: good visibility however, the signals are installed side-by-side.

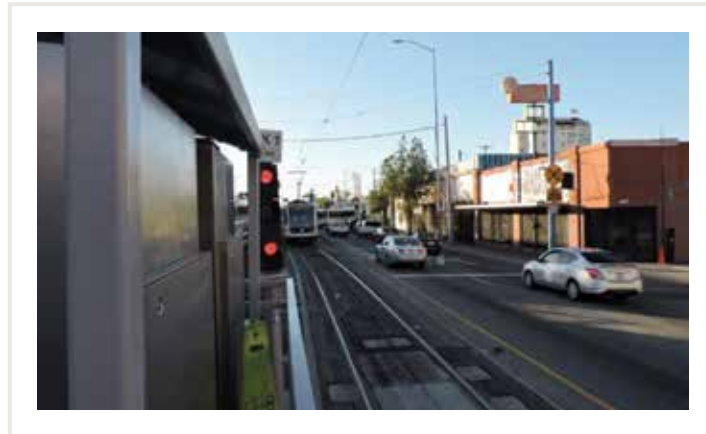
With respect to northbound signal 8N, it is partially obstructed by automatic vending machines installed at the north end of Grand/LATTC Station.

Based on the above, it is believed that poor visibility at Signal 8N contributes to red signal violations at Washington & Flower Junction. It is not clear who is responsible for re-establishing a route at signal 2S in the event of a misrouting condition. A lack of consistency or uncertainty related to route setting could lead to false expectation that a signal would clear.

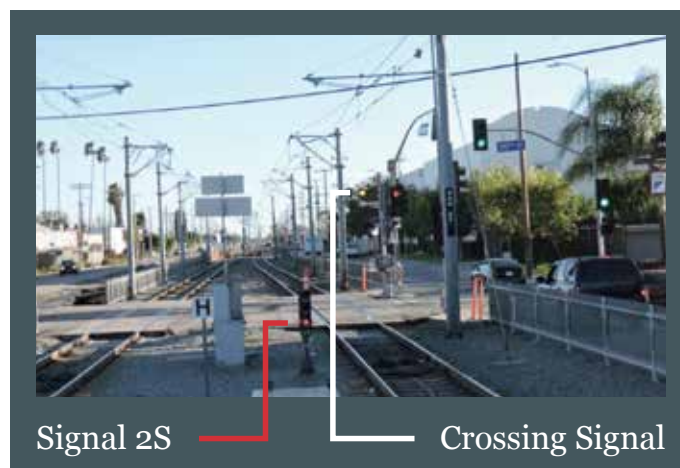
The current crossing gate indications are fine provided that they are used consistently and explained in the operating rules and procedures. The issue is one of coordinating cross gate indication with interlocking signal indication.

- There is potential for human error due to frequent occurrence of gate failure, and the need to rely on rules and procedures to operate through the crossing,
- Signal 2S is not clearly visible. The Stop Signal Working Group recommended to either raise the signal, or relocate it to the platform.

- Signals 5N and 2S are located on the left side of the track, and are clearly visible as a train approaches the signals. However, there is a case in the approach of Signal 2S, which partially obstructs the signal from the station platform. As indicated above the Stop Signal Working Group recommended raising the signal.

- Conflicting indications between Signal 2S and crossing signal,
- Obstructed visibility of Signal 2S, and
- Frequent occurrence of gate failure.

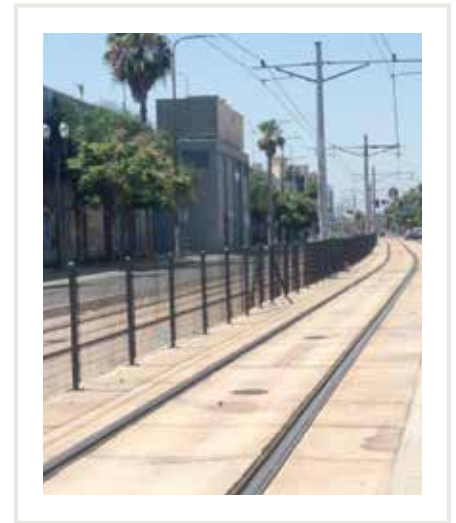
The normal and reverse running signals 2S & 4S are installed side-by-side, and are located in the approach to the 21st Street intersection. A traffic Bar Signal is located at the far right corner of the intersection, and operates independently of the interlocking signals. The ROC Controller SOPs indicate that this interlocking does not have an “Automatic” mode and that during normal operation, the interlocking remains in “Central” mode with signals 2S and 4N fleted.

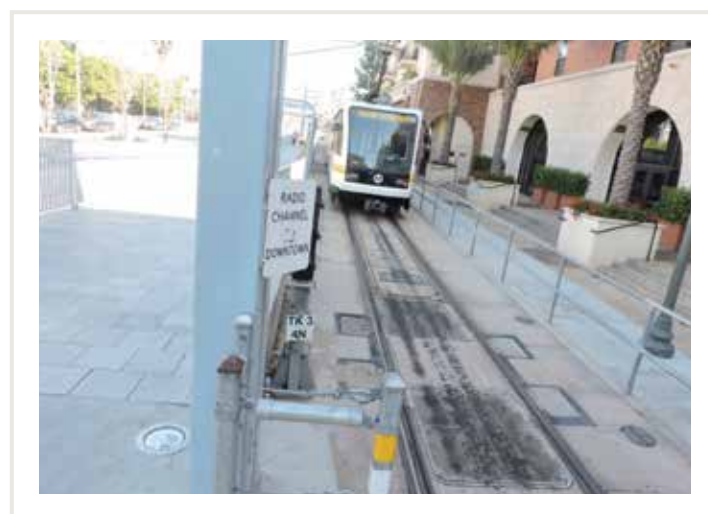
- Reverse running signal 4S is installed on the right side of the track,
- There is a slight curve in the approach to signal 2S, and
- A “radio” sign is partially obstructing signal 4N at the north end of the station.

The Stop Signal Working Group did identify the curve in the approach to Signal 2S as a potential contributor to red signal violation. It was indicated that it is difficult to see the signal from 500 feet. However, the signal representative indicated that there is a restricted speed approaching the station, and train operators should be slowing down.

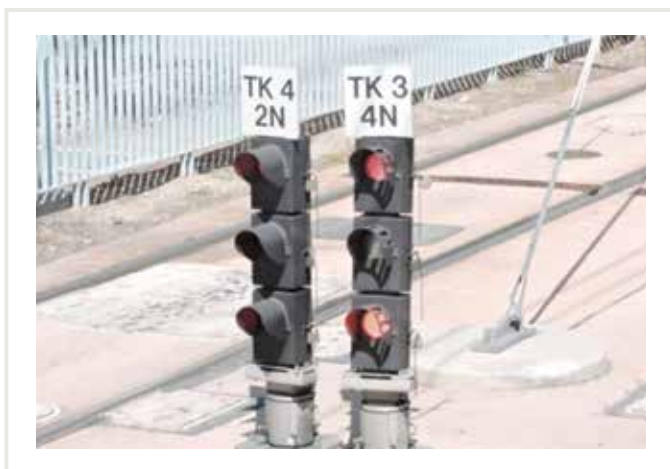
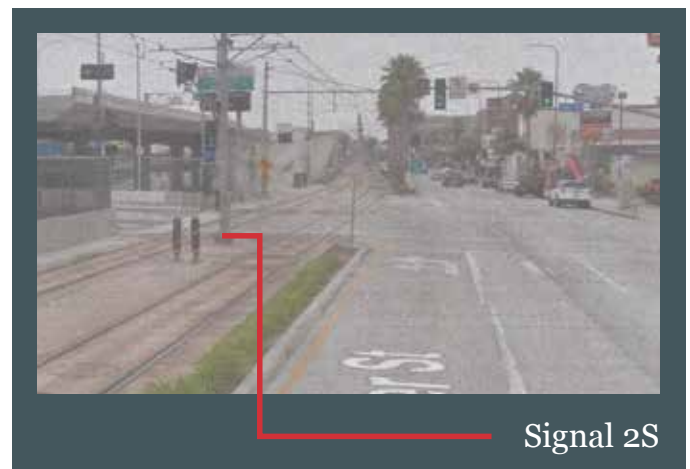
- Reverse running signals 2N & 4S are installed on the right side of the track,
- Good visibility for signals 2S & 4S. However, there is a slight curve in the approach to the signals, and
- Good visibility for signals 2N & 4N.

The Stop Signal Working Group made reference of the curve in the approach to Signals 2S & 4S. The group also observed that Signals 2N & 4N are too low and recommended raising the signals.

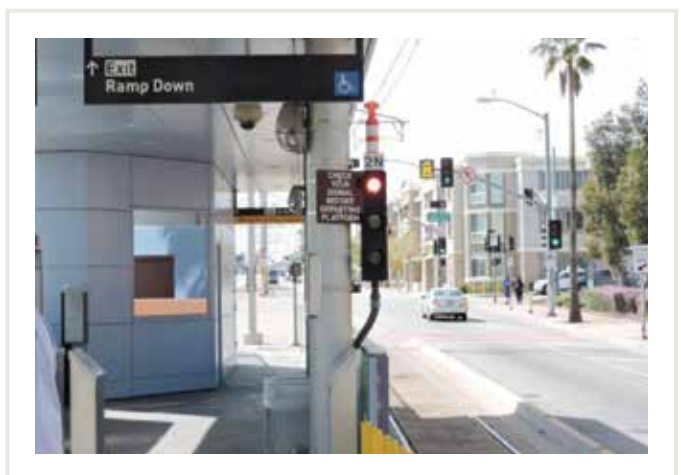
- Reverse running signal 2S is installed on the right side of the track,
- Good visibility for signals 2N & 4N, and
- Good visibility for signals 2S & 4S.

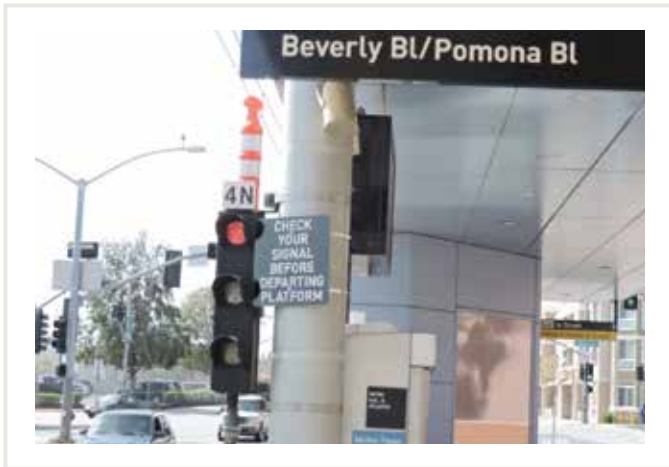
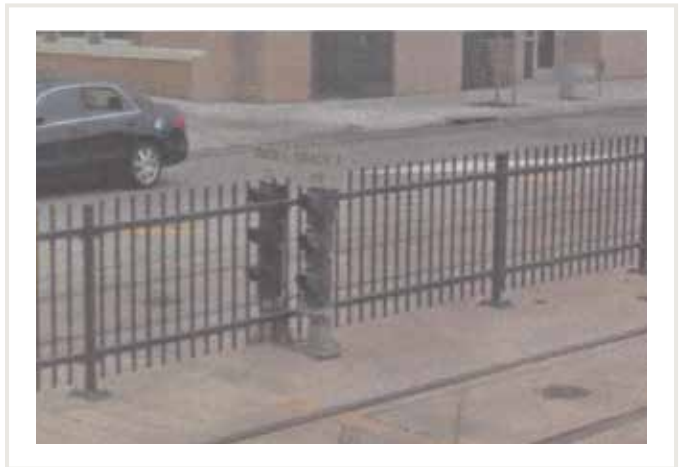
The Stop Signal Working Group made a number of observations related to the angle/orientation at the various signals. Further, the group questioned if the 500 feet sighting distance requirement is satisfied at signals 2S & 4S.

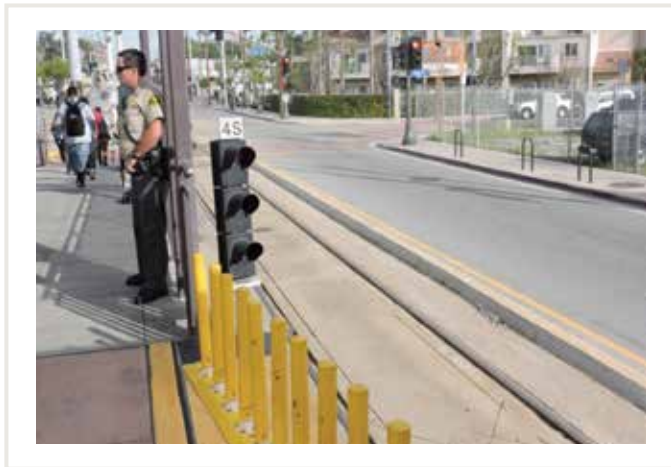
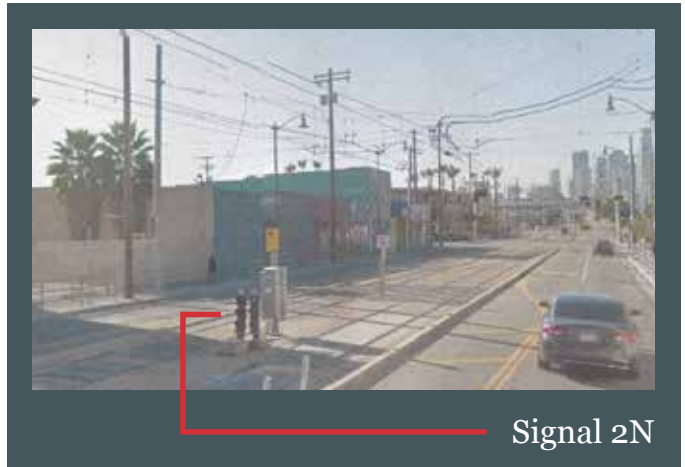
The Stop Signal Working Group noted that the barrier is partially obstructing the view of Signal 4S.

There are no site specific factors that contribute to red signal violations. Although Signal 4S is partially obstructed, the signal is visible when a train is stopped at the station. However, similar to other locations, there are operational factors that can contribute to the violations:

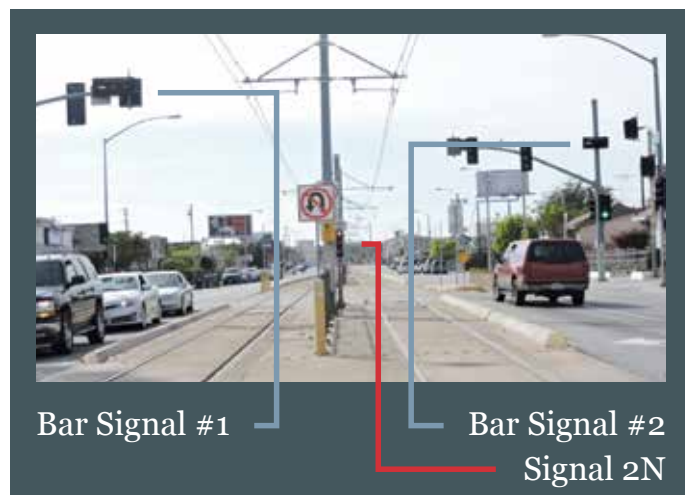
A review of the red signal violation reports during the years 2010 through 2015 indicates that nine (9) red signal violations took place at Ditman Interlocking.

Metro investigated these violation incidents and concluded that the root causes for all nine incidents are attributed to “Operator Inattention”. No contributing factors were reflected in the reports.

In view of multiple violations at this location, our team conducted a number of interviews with Metro’s Operations personnel, and inspected the physical signal installation to determine if there are other factors that contributed to the violations. Further, our team reviewed the Site Visit Reports provided by the Metro’s Stop Signal Working Group, as well as the ROC Controller SOPs and the Gold Train Operator SOPs.

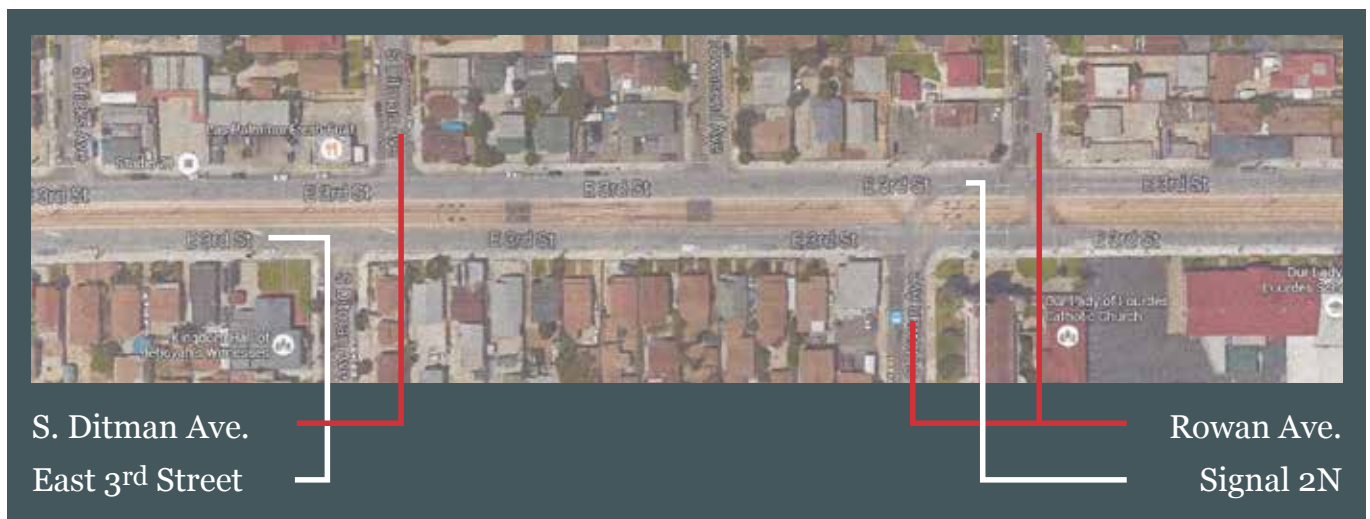
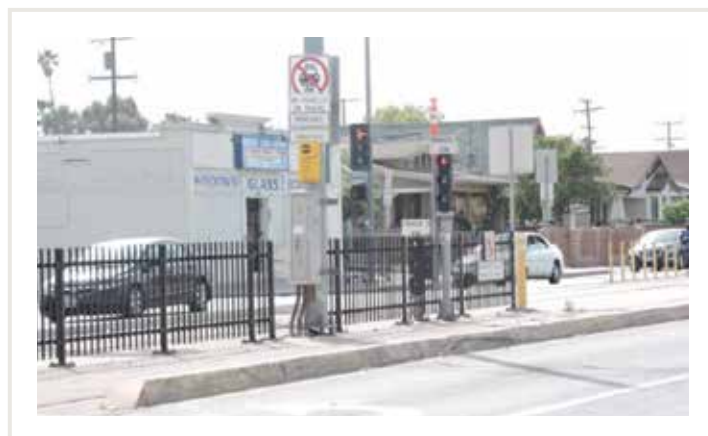
With respect to the operational characteristics at Ditman Interlocking, this location has similarities to other interlocking locations within street running territory. The normal and reverse running signals 2N & 4N are installed side-by-side. Based on description in the ROC Controller SOPs, Signals 2S, 4S, 2N and 4N have approach clearing if the interlocking is operating under “Automatic” mode. However, a review of the incident reports does not reveal the mode of operation in effect at the time of the violation incidents.

Signal 2N, where all the violations occurred, is located between two street intersections with Rowan Ave. There is a first Bar Signal (#1) located at the left side of the track in the approach to signal 2N, and a second Bar Signal (# 2) located at the right side of the track in front of Signal 2N. Similar to other locations, interlocking signal 2N and the Bar Signals operate independent of each other.

A54: Metro should investigate the feasibility of relocating Signals 2N and 4N to the south side of the first Rowan intersection. It should be noted that the installation of an approach signal to Signal 2N does not provide advance indication to train operators because Signal 2N is approach clearing and will normally display a “stop” aspect without a train present on the approach track circuit.
