**Board Report**

**SYSTEM SAFETY, SECURITY AND OPERATIONS COMMITTEE
JULY 16, 2015****SUBJECT: REPAIR/REPLACE GATEWAY FIRE SPRINKLER SYSTEM****ACTION: APPROVE USE OF DESIGN-BUILD CONTRACTING DELIVERY APPROACH****RECOMMENDATION**

Key Observations from Ultrasonic Inspection

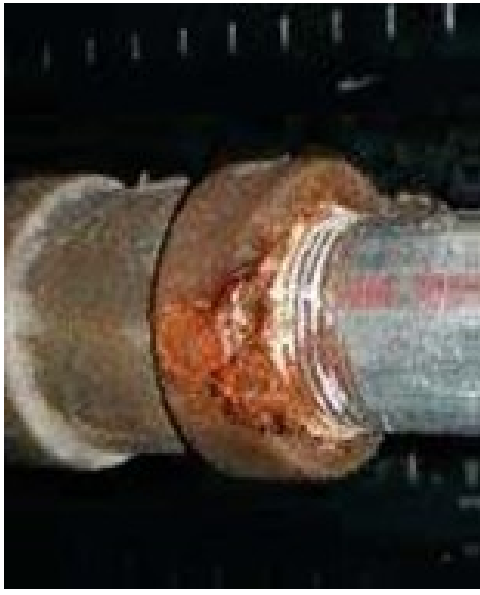
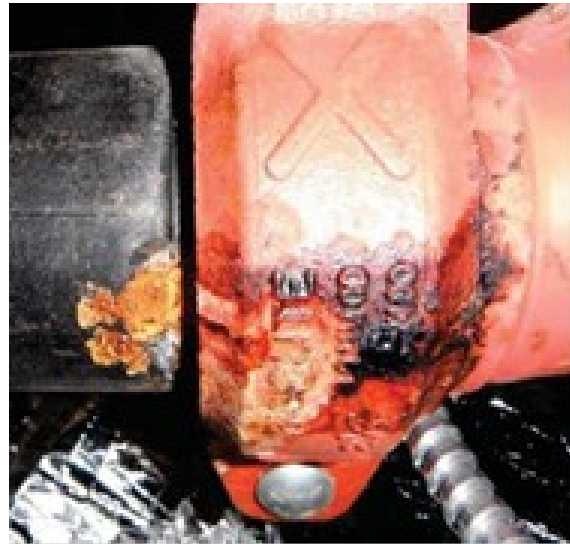
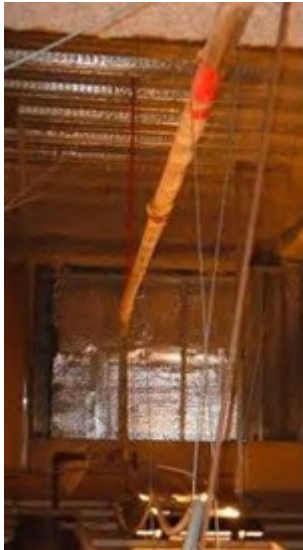
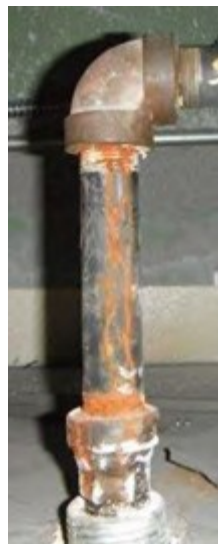
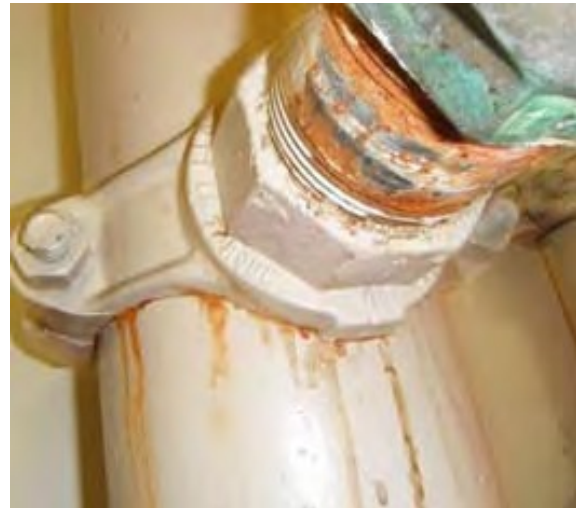
Photos of Fire Sprinkler System Components at Time of Ultrasonic Testing

A preliminary engineering study, including ultrasonic wave scanning, determined that approximately 65% of building fire sprinkler lines have enough corrosion to warrant replacement. The report from the engineering survey also identified the following issues:

- Some of the piping was thinner than was the standard expected;
- Seeping moisture was found throughout the entire building;
- The 3" main vertical drain running the length of the building showed excessive corrosion;
- Air was found on every floor throughout the building. Trapped air and water within a pipe system creates an environment for additional corrosion;
- Water was found in dry systems; and
- A corrosion inhibitor should be used to extend the life of the existing piping; however severely pitted (corroded) pipes should be replaced with new.

- Seeping seams found throughout building on threaded branch lines.
- 3-inch drain pipes running the length of the building showed severe issues..
- Over 65% of piping has interior wall loss of 11% or more.
- Air found within wet pipes on all floors.
- Trapped water found within pipes in the dry systems.

The Fire Sprinkler Piping Replacement Project will remove existing compromised fire sprinkler piping and replace with new piping. Metro is authorized to enter into design-build contracts pursuant to Public Utilities Code Section 130242 upon approval from the Board as set forth in the Recommendation.

The design build contractor will work with Metro staff and the engineering consultant to design and schedule the replacement of the compromised fire sprinkler piping with little to no impact on the building occupants.
